Preliminary Information

PIT5318E Wind Buffeting Drone Type Noise and/or Water Leak Models

Brand:	Model:	Model Years:	VIN:		Engine:	Transmissions:
			from	to		
Cadillac	Escalade	2015 - 2018	All	All	All	All
Chevrolet	Suburban	2015 - 2018	All	All	All	All
Chevrolet	Tahoe	2015 - 2018	All	All	All	All
GMC	Yukon	2015 - 2018	All	All	All	All

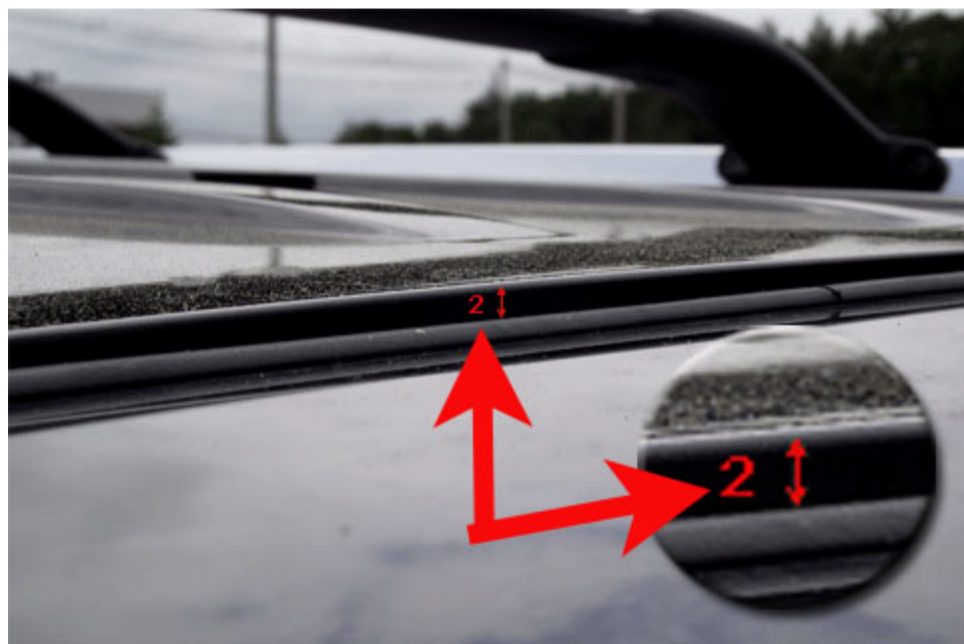
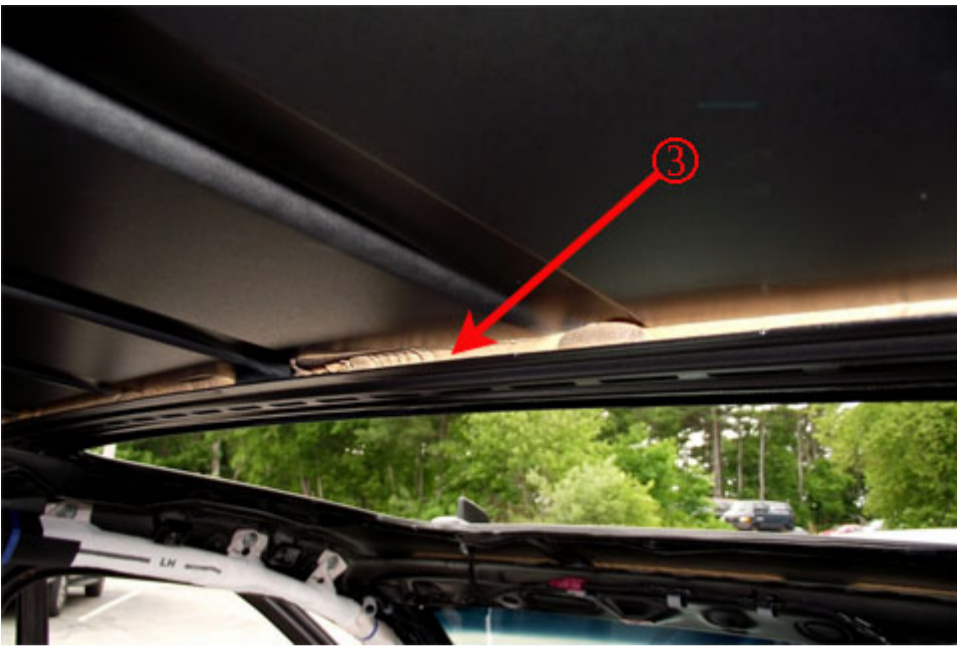
On some sunroof equipped trucks, customers may comment of a buffeting/wind noise and/or also notice a water leak from the headliner area near the sunroof. It may be found that the rear edge of the sunroof glass is considerably lower than the roof (2), even after performing a sunroof glass height adjustment. This excessive over-crown / gapping between the sunroof glass and roof may be due to the roof sheet metal being detached from the roof bow directly behind the sunroof opening (3).

Note: The bonding material is not intended to contact the roof at the raised reinforcement ribs.

- 1) Remove the headliner to access the underside of the roof.
- 2) Remove the sunroof assembly.
- 3) Provide protection for the carpet and seats beneath the roof bow.
