SERVICE BULLETIN

Classification:	Reference:	Date:
EC18-013	NTB18-040	June 7, 2018

2017-2018 TITAN; AIR CONDITIONING BLOWS HOT AIR AFTER EXTENDED IDLING OVER 100°F

APPLIED VEHICLES: 2017-2018 Titan (A61)
APPLIED ENGINE: VK56VD (gasoline engine)
NOTE: Does not apply to Titan XD

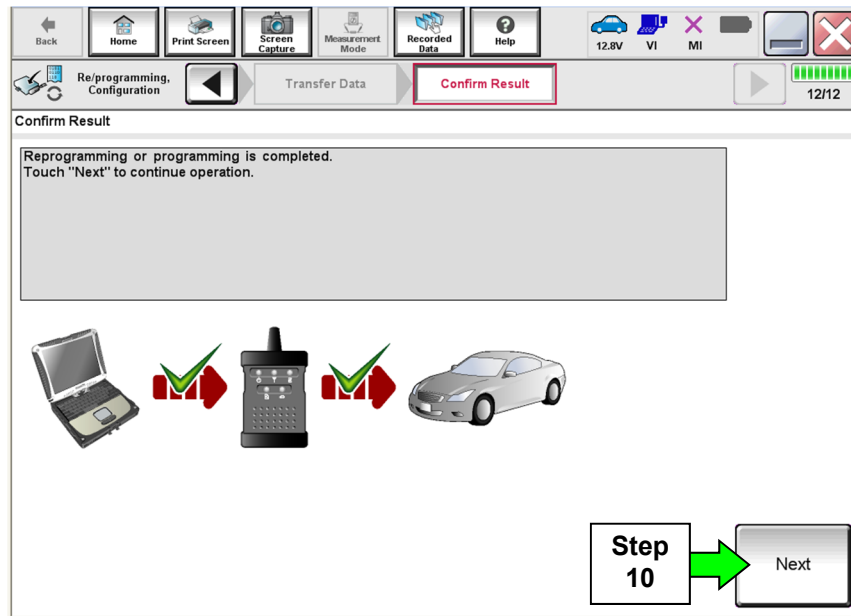
8. When the screen in Figure 5 displays, reprogramming is complete.

NOTE: If the screen in Figure 5 does not display (indicating that reprogramming did not complete), refer to ECM recovery on the next page.

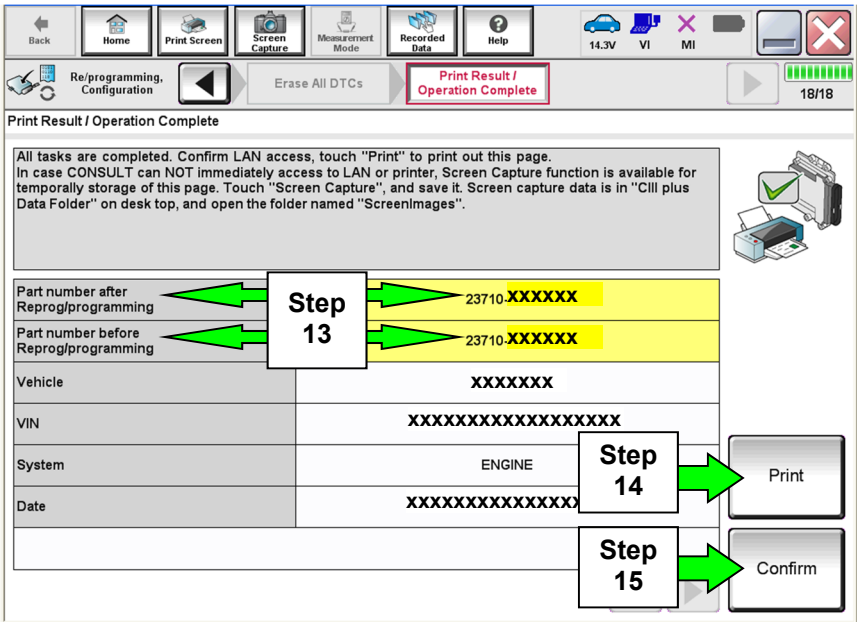
- 12. When the entire reprogramming process is complete, the screen in Figure 8 will display.
- 13. Verify the before and after part numbers are different.
- 14. Print a copy of this screen (Figure 8) and attach it to the repair order for warranty documentation.
- 15. Select **Confirm**.
