# SERVICE BULLETIN

BT18-008

## 2018 LEAF; FRONT DOOR WILL NOT OPEN

**APPLIED VEHICLES:** 2018 LEAF (ZE1)

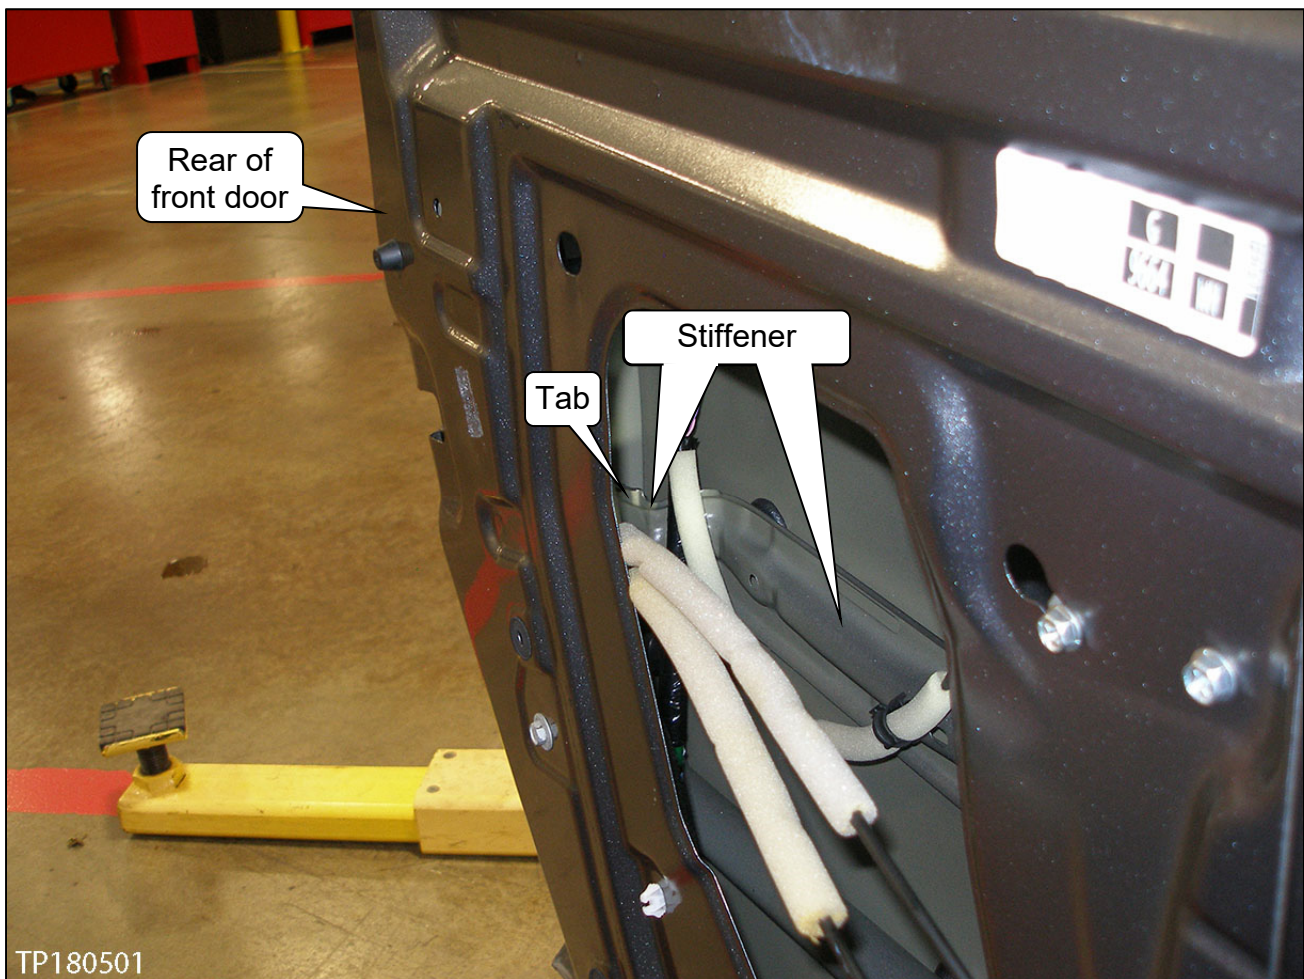
1. Remove the front door finisher of the affected door.
    - Refer to the Electronic Service Manual (ESM), section BODY INTERIOR-INTERIOR-INTERIOR-REMOVAL AND INSTALLATION-FRONT DOOR FINISHER for front door finisher removal.
- NOTE:** It may be intermittent that the door will not open. Attempt to open the door multiple times with both handles. If the door does not open normally, follow normal repair procedures for consequential damage during front door finisher removal (see Claims Information).
2. Connect the power window switch, and then close (roll up) the door glass.
  3. Access the tab stiffener and door latch lever.
    - Refer to Figure 1 below, and Figure 2 on the next page.

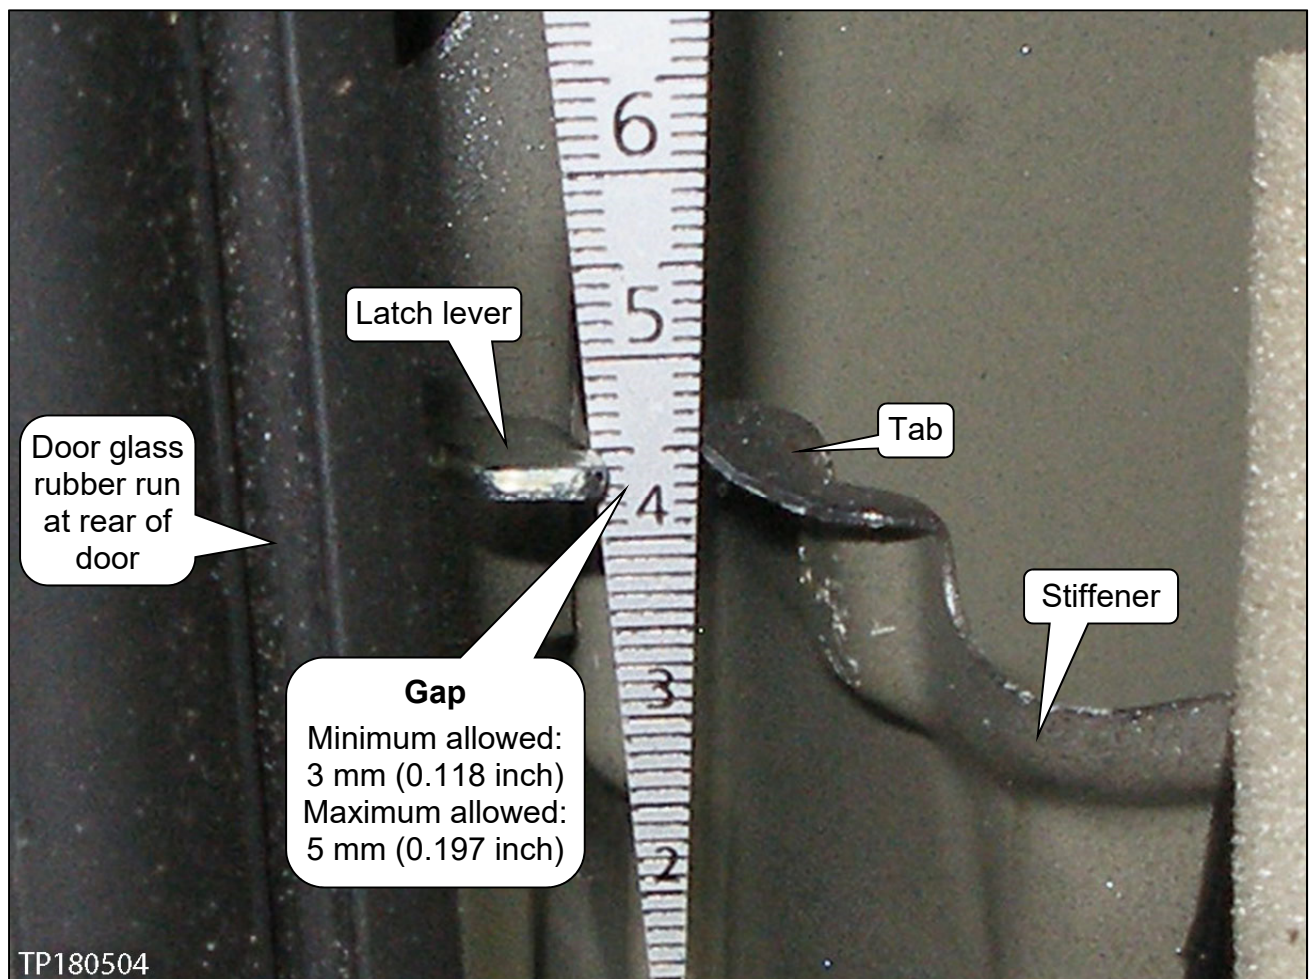
Figure 3

5. With the lever and stiffener tab still level with each other, inspect the gap between the latch lever and stiffener tab.

- Lever-to-door stiffener gap:

Minimum 3 mm (0.118 inch), maximum 5 mm (0.197 inch)
