**Fault P029900 Stored In The DME Due To Loose Vacuum Line**

Binder – 2 – Engine-Electric  
This bulletin replaces ATI Grp 2 1702  
published on April 6, 2017.

Vehicle Type: **Panamera 4S/Turbo (971)**

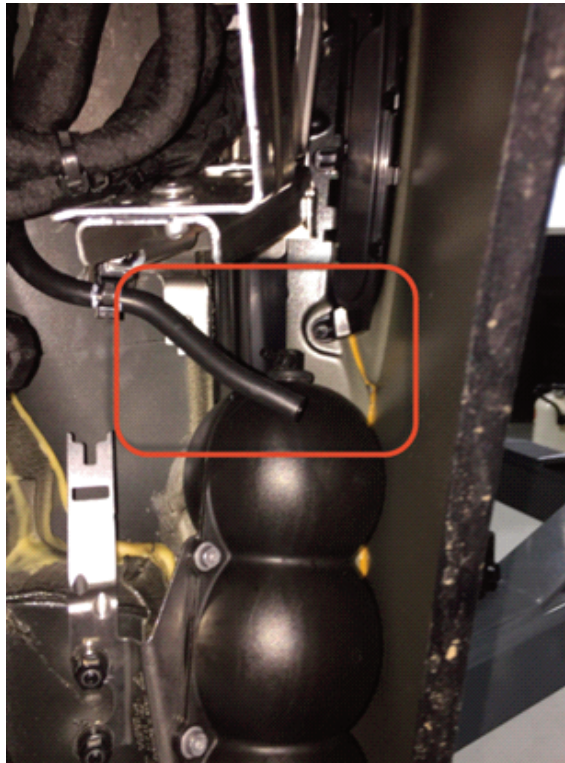
Issue: Fault **P029900-Turbo/Super Charger Underboost** stored in the DME.

Information: A vacuum line at the vacuum reservoir in the left front wheel well was not connected properly during production and may become disconnected (see the picture below). The repair is to simply reconnect the line and make sure it is not under tension.
