Oil Ingress Into The Engine Wiring Harness

This bulletin replaces ATI Grp 9 1306,
published on July 17, 2013.

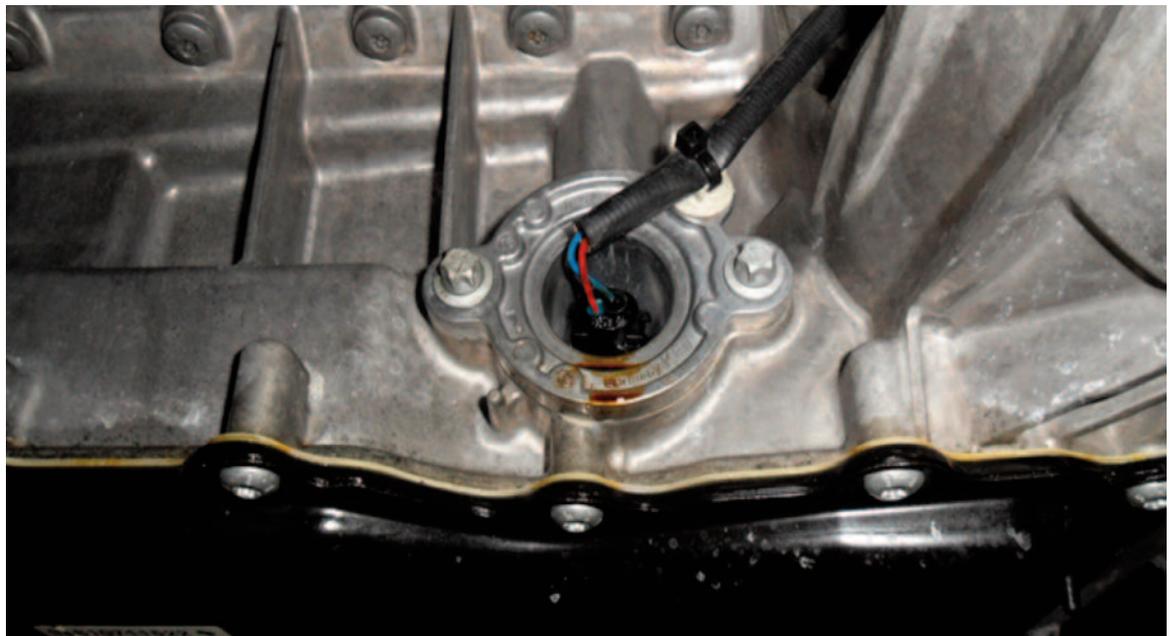
- Vehicle Type: **Cayenne, Panamera (except hybrid) and Sports Cars**
- Model Year: **Cayenne: 2008 and up, Panamera: 2010 and up, Sports Cars: 2009 and up**
- Part Number: Various
- Issue: Oil in the wiring harness.
- Information: If oil is found in the engine wiring harness during a repair, the wiring harness and all the affected components (including the oil pump control valve) must be replaced.
