Recall Campaign Bulletin

Campaign No. 2018070002, June 2018

SUBJECT: Model 447 (Metris), Model Year 2015 - 2017

Transmission Carrier Attachment

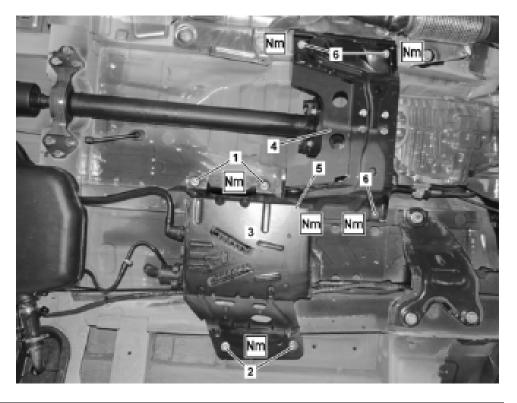
Daimler AG, the manufacturer of Mercedes-Benz Metris vehicles, has determined that in certain vehicles (Platform 447), the screw connection of the transmission carrier to the vehicle body may not be tightened with the specified torque. If the screw connection of the transmission carrier is not sufficiently torqued, the bolts could loosen and subsequently lose connection with the vehicle. In that event, the position of the transmission carrier and the angle of the propeller shaft to the transmission could change. If this angle exceeds a certain degree, the joint disc could be damaged and lead to its complete failure. The customer will be alerted to clear warning signs of vibrations and rattling noises during operation of the vehicle prior to such loss of power. In this case, the vehicle would remain controllable (steering and braking would not be affected). However, an increased risk of a crash cannot be ruled out. An authorized Mercedes-Benz dealer will perform a check of the bolts on all potentially affected Metris vehicles and replace the bolts if necessary.

- 1 Bolts
- 2 Bolts
- 3 Activated charcoal canister bracket
- 4 Transmission carrier
- 5 Screw
- 6 Bolts

| 4 | Unfasten bolts (2) of activated charcoal canister holder (3) by a few turns. | Do not stretch electric lines as well as hoses and lines of activated charcoal canister. Damage may occur otherwise. i To gain access to the bolt (5), release bolts (2) only. The bracket for the activated charcoal canister (3) remains mounted to the vehicle. |
|---|--|---|
| 5 | Check torque of bolts (5, 6) of transmission carrier (4). | When checking the torque none of the bolts (5, 6) may turn before the torque value is reached. If one of the bolts (5, 6) turns replace it. Otherwise, the correct tightening torque for the respective bolts (5, 6) cannot be assured. Nm Bolt, transmission carrier to longitudinal member If bolts (5, 6) turn before the torque value is reached. Replace relevant bolts (5, 6). |

| Check | | |
|---|---|--|
| 3 | Remove bolts (1) of activated charcoal canister holder (3). | |

| 4 | Unfasten bolts (2) of activated charcoal canister holder (3) by a few turns. | Do not stretch electric lines as well as hoses and lines of activated charcoal canister. Damage may occur otherwise. i To gain access to the bolt (5), release bolts (2) only. The bracket for the activated charcoal canister (3) remains mounted to the vehicle. |
| 6 | Screw bolt (1, 2) into activated charcoal canister holder (3). | Nm M8 |
