RECREATIONAL VEHICLE SERVICE CAMPAIGN

SERVICE ADVISORY 18-323

Laredo Travel Trailer Awning Hardware

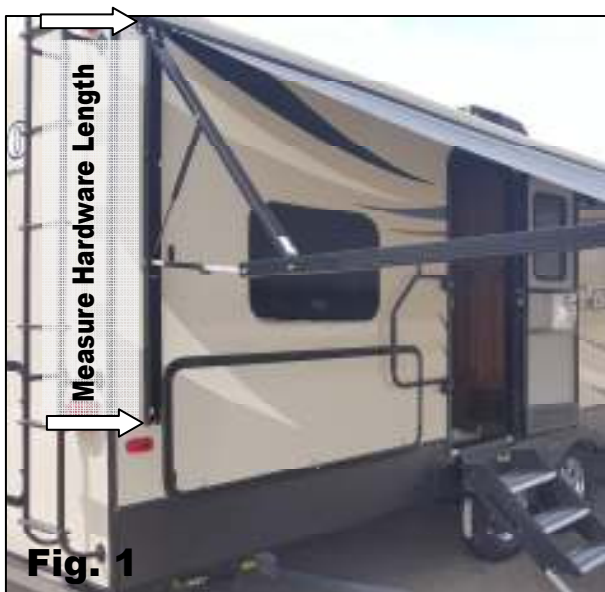
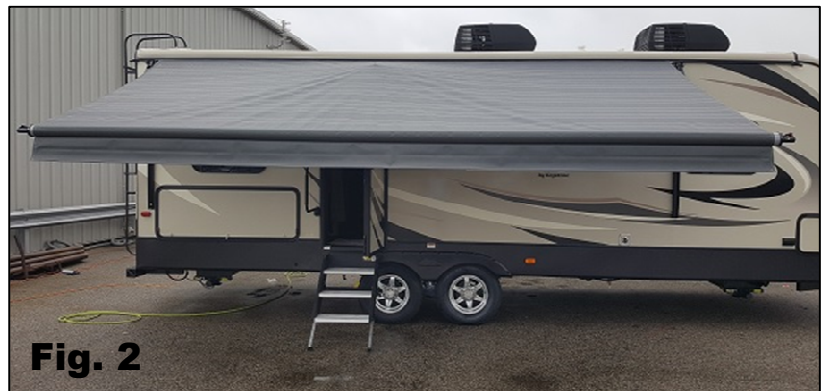
The remedy is to verify the type of hardware that is currently on the vehicle and, if needed, change the current fifth wheel hardware with the proper travel trailer hardware. If **fifth wheel hardware (62 ¼")** is installed, the roller tube will drop approximately 32 inches when fully extended, this is the incorrect hardware, see Figures 1 & 2. If the **travel trailer hardware (65 ½")** is installed, the roller tube will only drop approximately 4 inches when fully extended, this is the correct hardware.

Fully extend the awning and measure the arm that is attached to the sidewall. The correct hardware should measure approximately 65 ½" in length. For 332BH models equipped with an awning on the slide room, inspect that hardware along with the hardware installed on the sidewall. It should be obvious if the hardware is incorrect according to the height of the roller tube from the ground when fully extended, see Figure 2.

Replace the incorrect hardware according to industry standards with the correct part #504408.
