SERVICE BULLETIN

APPLICABILITY: 2015-2018MY Legacy and Outback NUMBER: 02-171-18R

DTC P0072 / Additional Insulation for Ambient

Air Temperature Sensor

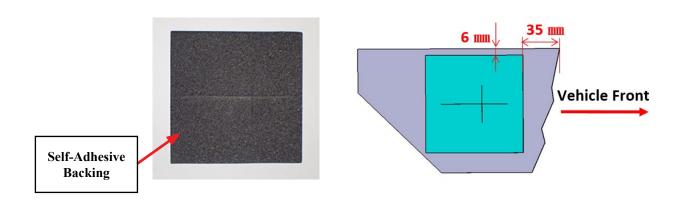
This bulletin provides a service procedure for installation of additional foam packing to enhance performance of the Ambient Air Temperature Sensor. The additional foam better insulates the sensor from engine compartment heat which may lead to setting a DTC P0072. This information is applicable to models with or without the Active Grill Shutter (AGS) system.

Step 4: Prepare the new (additional) self-adhesive foam packing. There are 2 cuts in the new part as shown. **IMPORTANT:** The vertical cut must be positioned toward the front of the vehicle and the intersection point of the cuts aligned with the hole in the existing foam packing. Use a permanent marker to make some alignment marks for positioning the new foam using the dimensions shown on the illustration below as a guide. Peel the backing and apply the new foam to the existing foam packing. Press your finger along the foam while supporting it from the other side where the adhesive backing is to ensure it is fully seated against the existing foam.
