# 18157 Rear-Mounted Fuel Tank Sender Unit (Fuel Level Sensor) Replacement

Reference Number: N182163850 Release Date: June 2018 Revision: 00

Model Year			
Make	Model	From	То	RPO	Description
Chevrolet	Low Cab Forward 3500HD, 4500HD, 4500XD, 5500HD, 5500XD	2017	2019	4JJ1 4HK1	3.0L Diesel Engine 5.2L Diesel Engine

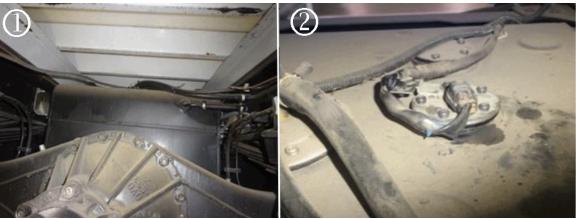
5082303

Access the top of the fuel tank by sliding underneath the vehicle from the driver's side directly in front of the rear axle/wheel. Facing rearward, position yourself beside the driveshaft to reach the Fuel Tank Sub Unit. (See Figures 1 and 2.)
