Customer Satisfaction Program

18189 Misrouted Chassis Harness

Reference Number: N172145310

Release Date: June 2018
Revision: 00

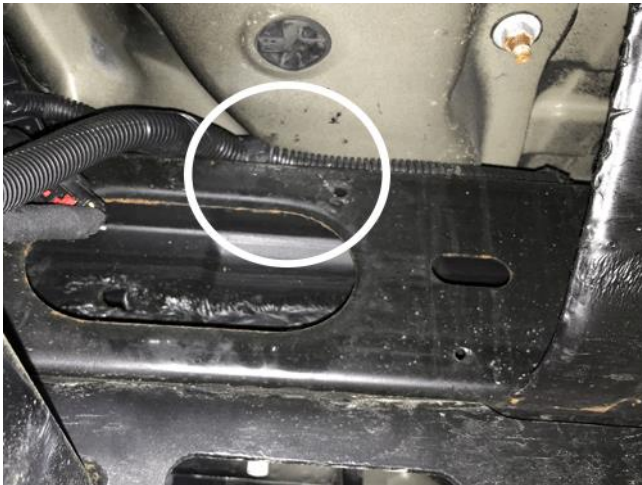
5087102

2. Locate the driver side chassis harness at the rear of the vehicle.
3. With a suitable tool, remove the chassis harness push pin retainer from the frame.
4. Inspect the wire harness for any damage. If any of the wires are pinched or damaged, repair the wires. Refer to *Wire to Wire Repair* in SI.

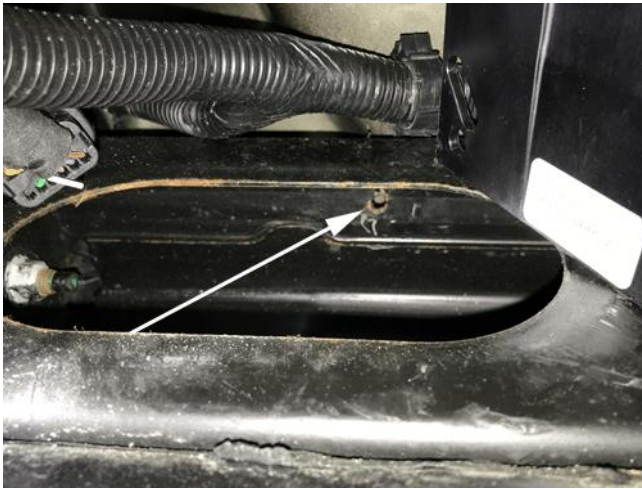
5087111

4. Inspect the wire harness for any damage. If any of the wires are pinched or damaged, repair the wires. Refer to *Wire to Wire Repair* in SI.
