# Customer Satisfaction Program

## 17386 SDGM and BYOM2+ Radio Software Updates

Reference Number: A172114410

Revision: 03

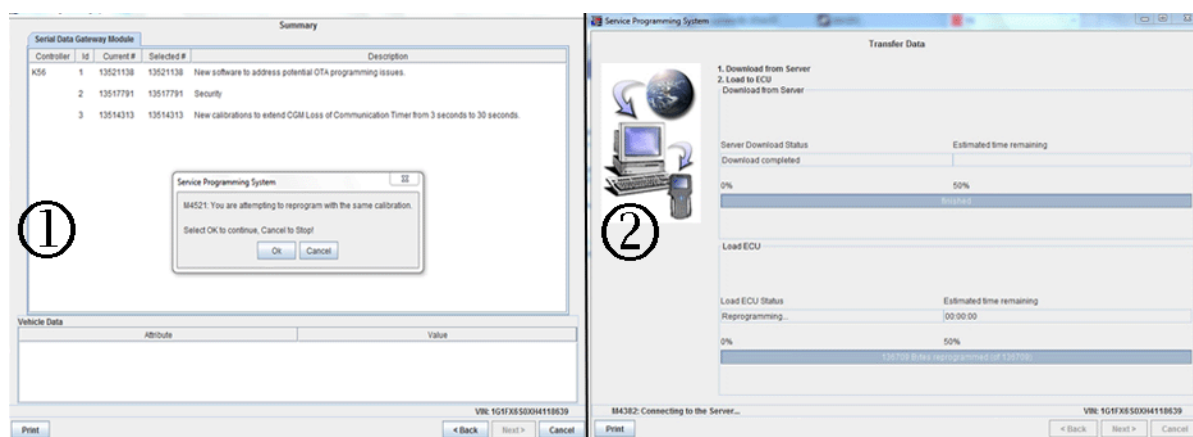
5024169

- If the K56 serial data gateway module has the same calibration already installed (1), select "Cancel" and continue to Step 2.
- If the K56 serial data gateway module needs to be updated, install the latest calibrations (2) and continue to Step 2.

1. Reprogram the K56 serial data gateway module. Refer to *K56 Serial Data Gateway Module: Programming and Setup* in SI.
