Service Update

18218 Propeller Shaft Disengage at Power Transfer Unit

Reference Number: N182162920

Release Date: June 2018

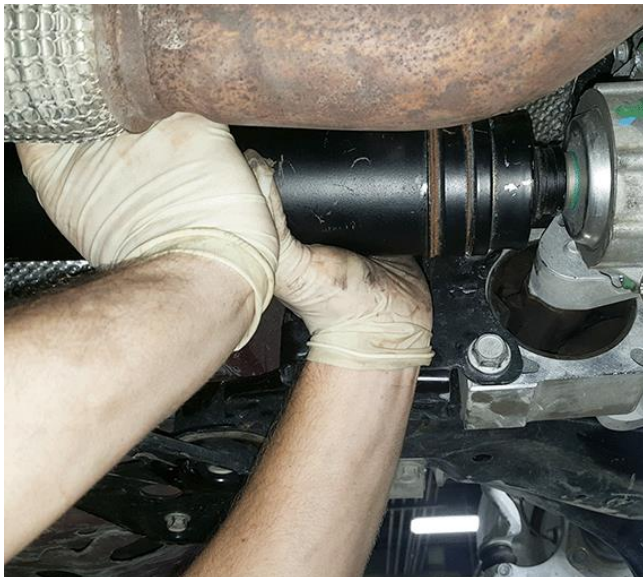
5116259

Condition	All 2017-2019 model year Buick Regal vehicles, equipped with AWD (RPO F46), may have a condition in which the front portion of the propeller shaft slips out of the Power Transfer Unit (PTU) and drags on the roadway. The driver may hear a dragging noise from beneath the vehicle, but there will be no driver information center/cluster warning messages.
Correction	Dealers are to re-seat the propeller shaft to the PTU and rear differential carrier assembly.

2. Using both hands, push forward firmly on the driveshaft several times as shown to ensure it is snapped into the Power Transfer Unit (PTU) fully.
