# Special Coverage Adjustment

## 18127 Driver's Front Seat Belt Anchor Pretensioner

Reference Number: N182153260

Release Date: June 2018  
Revision: 00

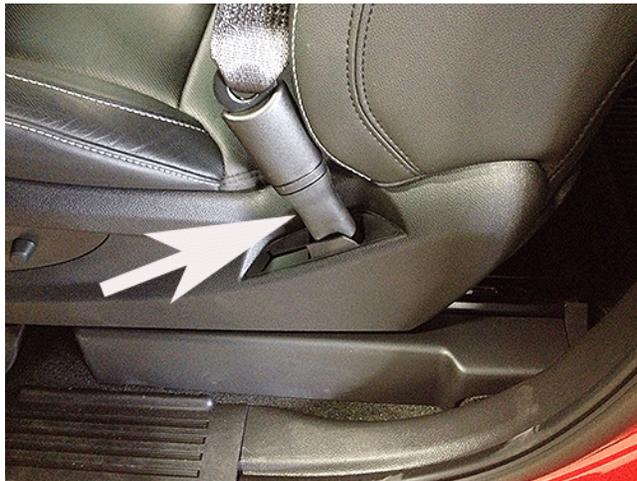
4522278

1. Move the driver seat to the full forward and full down position.

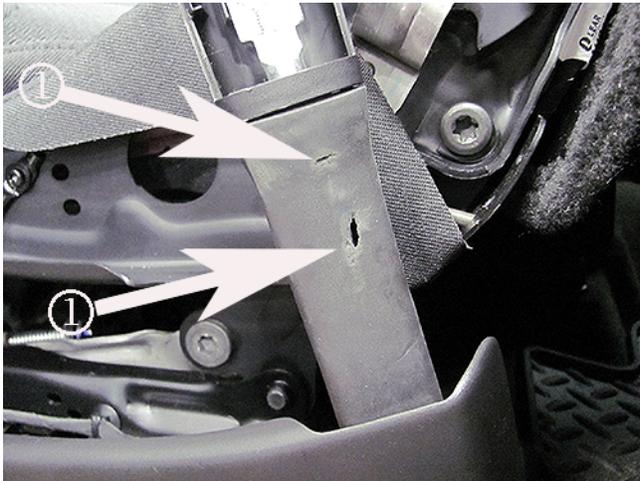
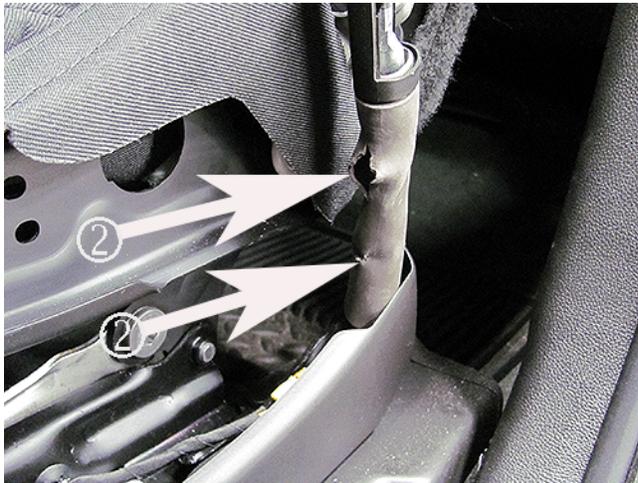
2. Inspect the seat belt tensioner cable cover for damage. Inspect the complete cable cover from the base of the cable to the buckle.

This damage will be in the form of holes (1) or splitting (2).

- If **any damage** is found, replace the driver side front seat belt anchor plate tensioner and the front seat cushion outer finish cover.
- If no damage is found, inform the customer that the special coverage condition is not present on their vehicle at this time.

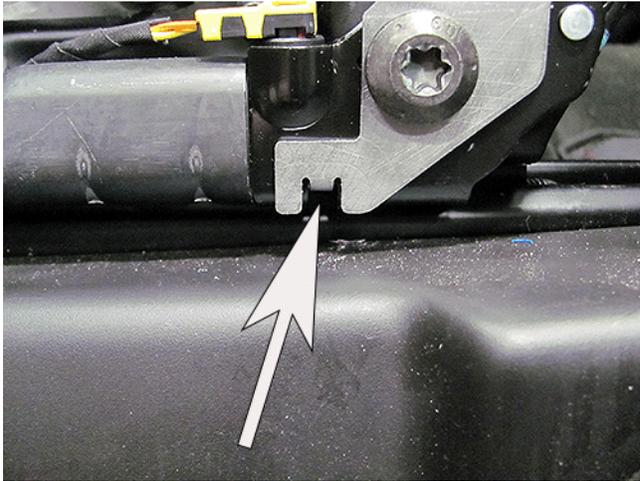
**NOTE:** If a tensioner bracket was installed as part of a previous service, discard the bracket. The new replacement front seat belt anchor plate tensioner design eliminates the need for the bracket.

1. Replace the driver side front seat belt anchor plate tensioner. Refer to *Front Seat Belt Anchor Plate Tensioner Replacement* in SI.
2. Replace the driver side front seat cushion outer finish cover. Refer to *Front Seat Cushion Outer Finish Cover Replacement* in SI.

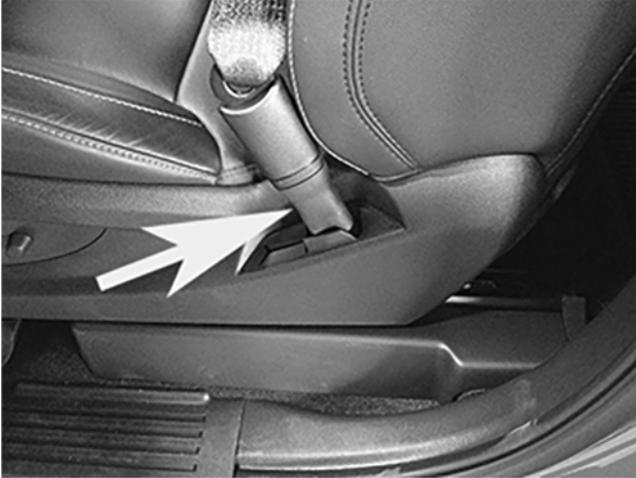
1. Move the driver seat to the full forward and full down position.

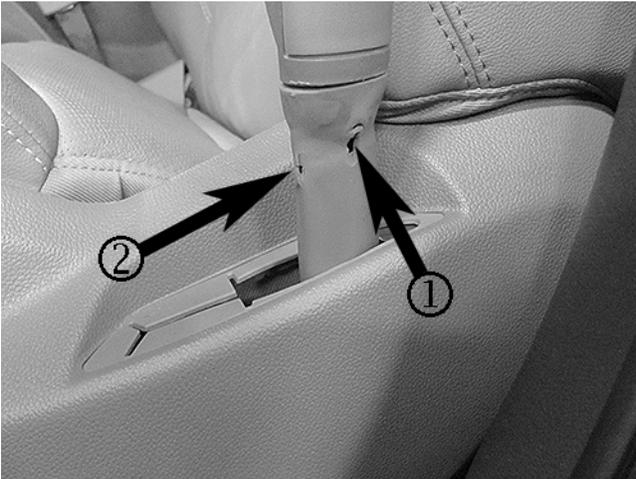
2. Inspect the seat belt tensioner cable cover for damage. Inspect the complete cable cover from the base of the cable to the buckle.

This damage will be in the form of holes (1) or splitting (2).

- If **any damage** is found, take the vehicle to the dealer for service.
- If no damage is found, the special coverage condition is not present on the vehicle at this time.
