Customer Satisfaction Program

18198 - Rear Axle Shaft C-Clips Missing

Reference Number: N18215893

Release Date: June 2018
Revision: 00

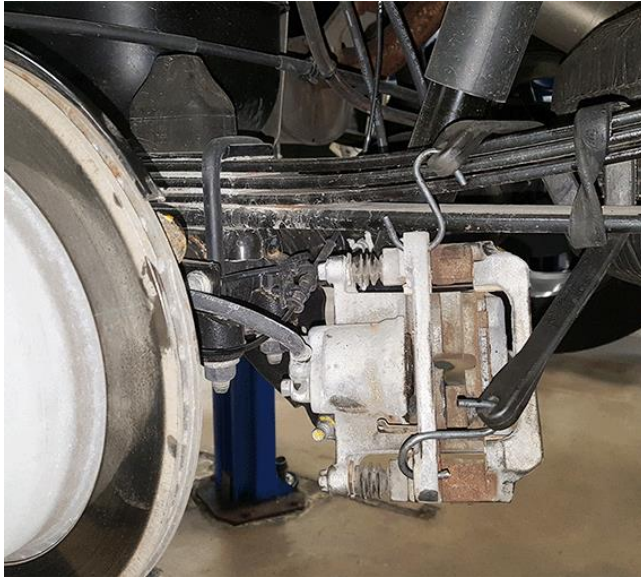
1. Remove both rear brake rotors. Refer to *Rear Brake Rotor Replacement* in SI. Hang the brake caliper from the leaf spring as shown to avoid damage to the brake line.

2. Pull on the axle shaft firmly to see if the axle shaft comes out.
 - If the rear axle shaft does not come out on either side, no further action is required. Reassemble the vehicle.
 - If the rear axle shaft can be removed on one or both sides, proceed to step 3.
3. Replace the C-Clip for the axle shaft or shafts that were found to be loose. Refer to *Rear Axle Shaft Replacement* in SI.
 - Inspect the brake components for the axle shaft in question (caliper, caliper bracket, rotor, pads) for potential damage caused by the lack of a C-Clip to hold the axle in place. If any damaged components are found, replace them as necessary.
