Preliminary Information

PIT5535C Service Front Camera / Service Lane Departure Warning / Service Lane Keep Assist Message with DTC B1008 SYM4B / IntelliBeam Headlight / Windshield Wind Rush Noise

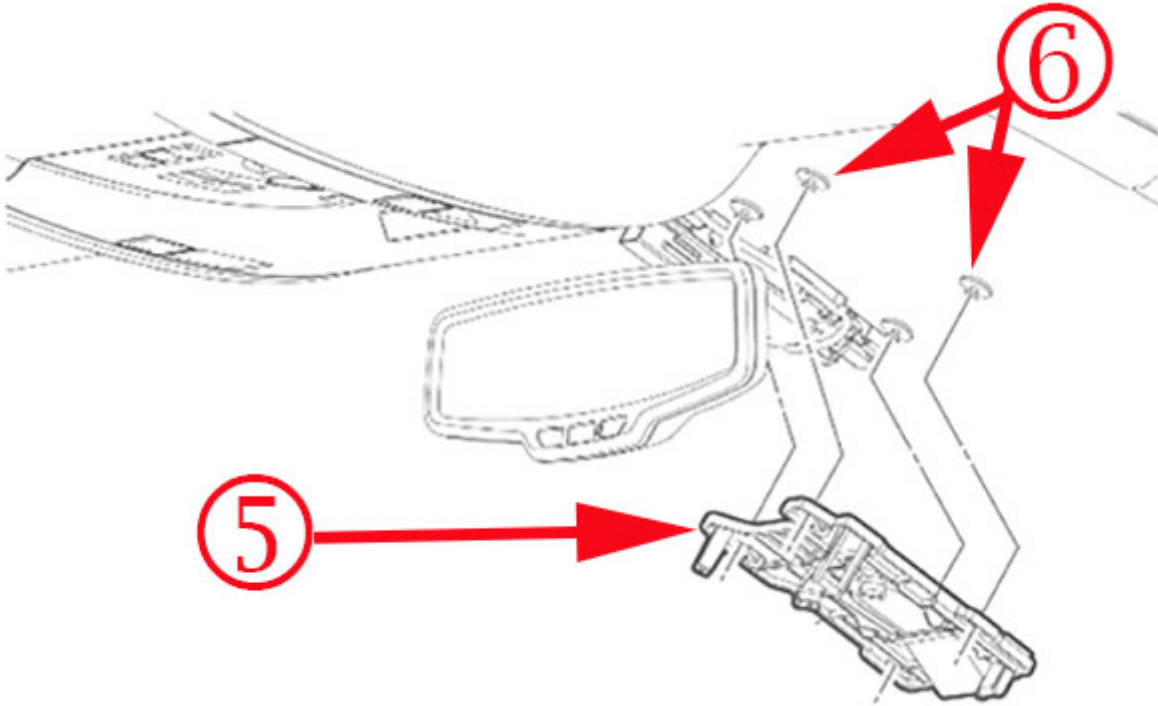
- **Verify the front view camera module bracket (5) is fully seated down and secured on the windshield pins (6), shown below.**

Do NOT replace the Front View Camera Module if it is only setting DTC B1008 SYM4B. Perform the following checks and repair as necessary:

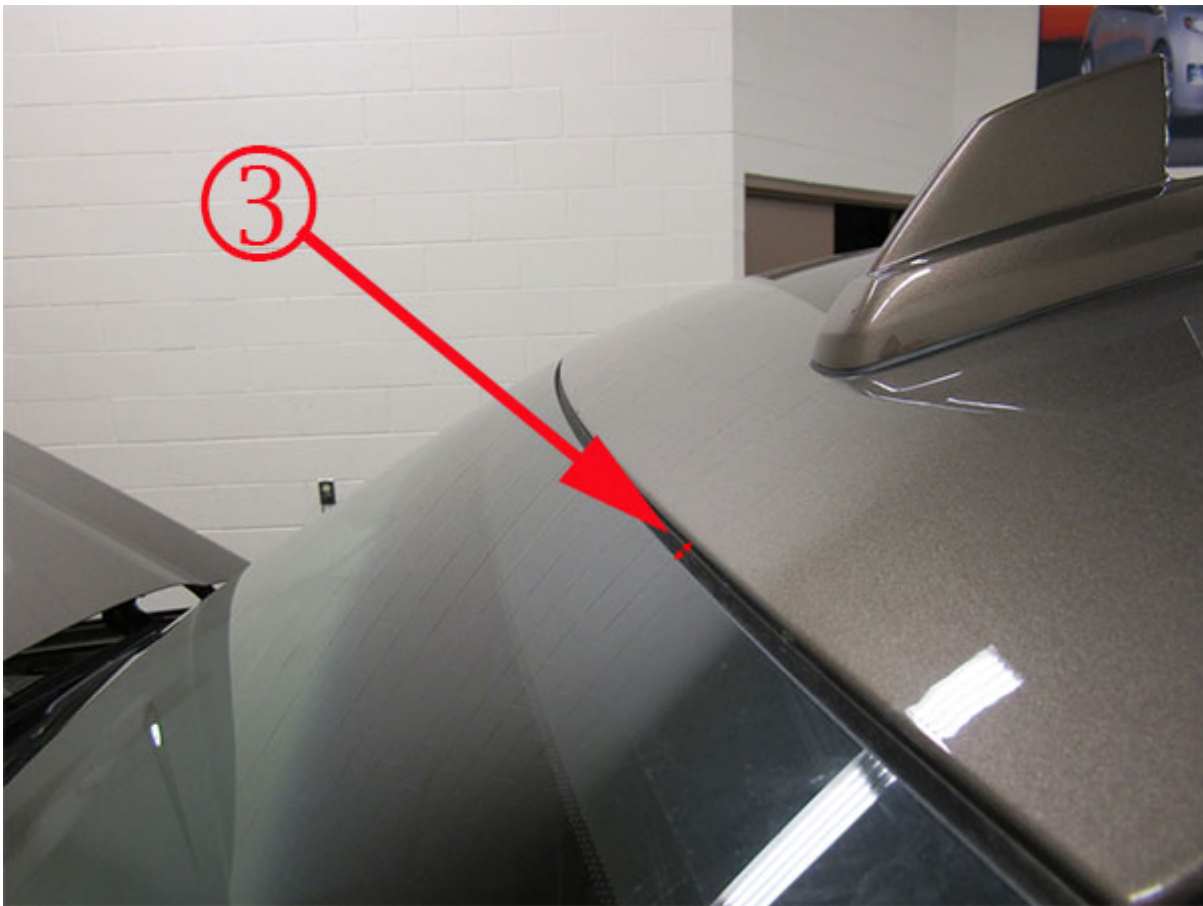
Inspect the gap between the top of the windshield and roof sheet metal (3), shown below. This gap should be 3.6 mm (+/- 1 mm).

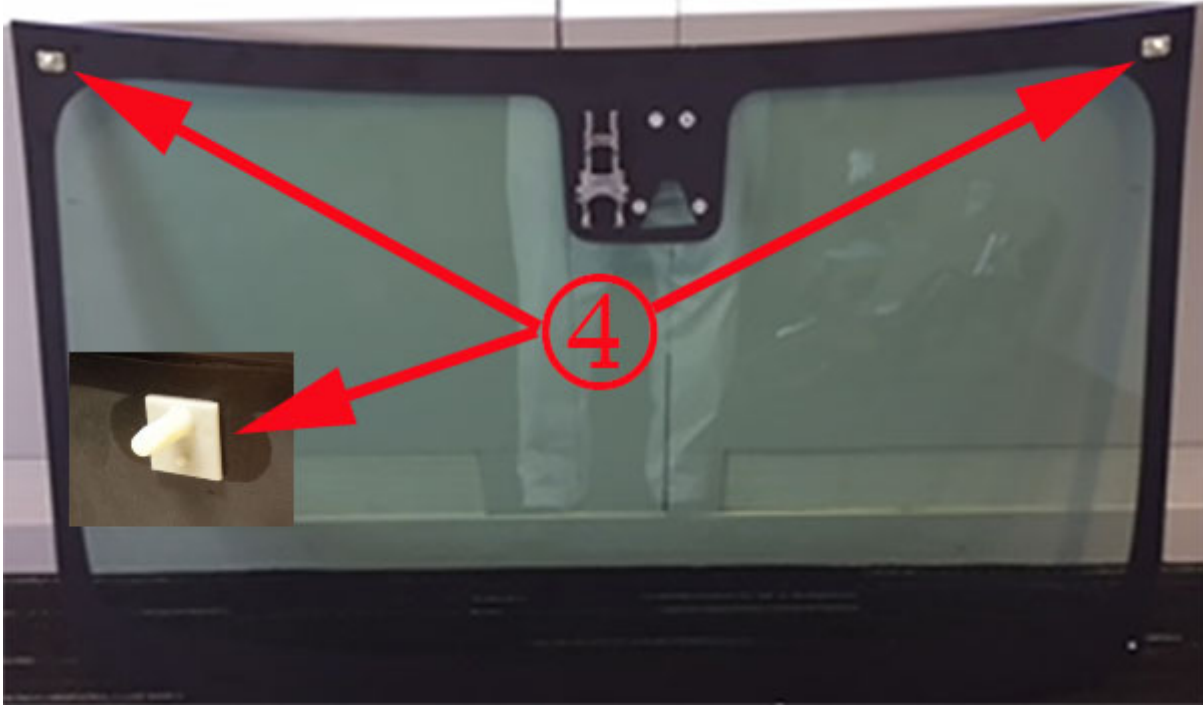
Factory GM windshields use alignment/locating pins (4) in the upper corners of the windshield, which makes it much easier to properly align the windshield to the body opening, shown below. Most aftermarket windshields do not use these alignment/locating pins, which can make it more difficult to ensure a proper installation.

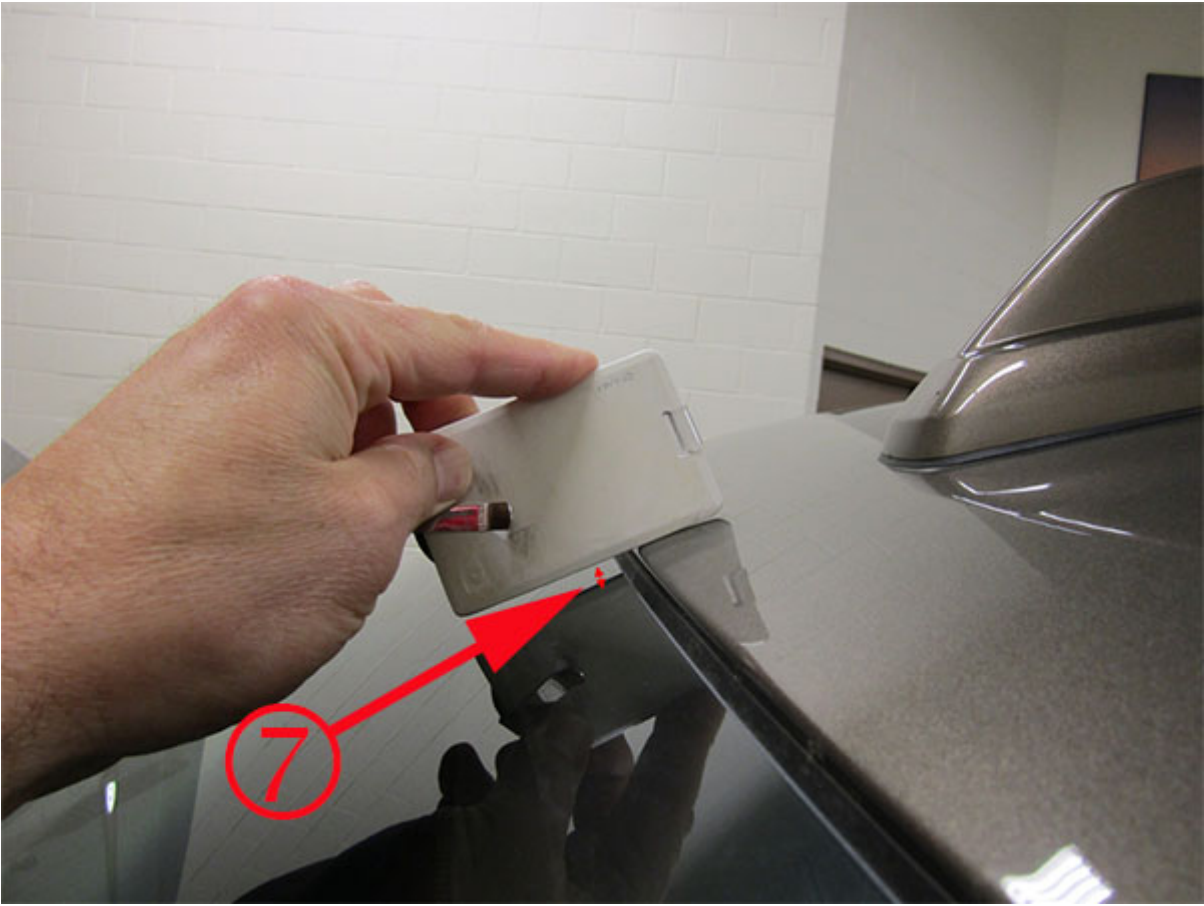
Also, inspect to make sure the windshield is sub-flush to the roof sheet metal (7), as shown below. If the windshield is proud of the roof sheet it could indicate:

- The old urethane adhesive bead was not cut low enough and left excessively thick.
- Windshield alignment/locating pin(s) are not fully in the alignment hole(s).
- During windshield installation it was not firmly pressed around the entire outside edge in order to wet-out the urethane adhesive bead.
- The urethane adhesive bead dried before the windshield was installed.

NOTE: A windshield proud of the roof sheet metal could cause excessive wind noise.

Either of these windshield mounting issues could cause the camera to be misaligned and

unable to complete the learn.

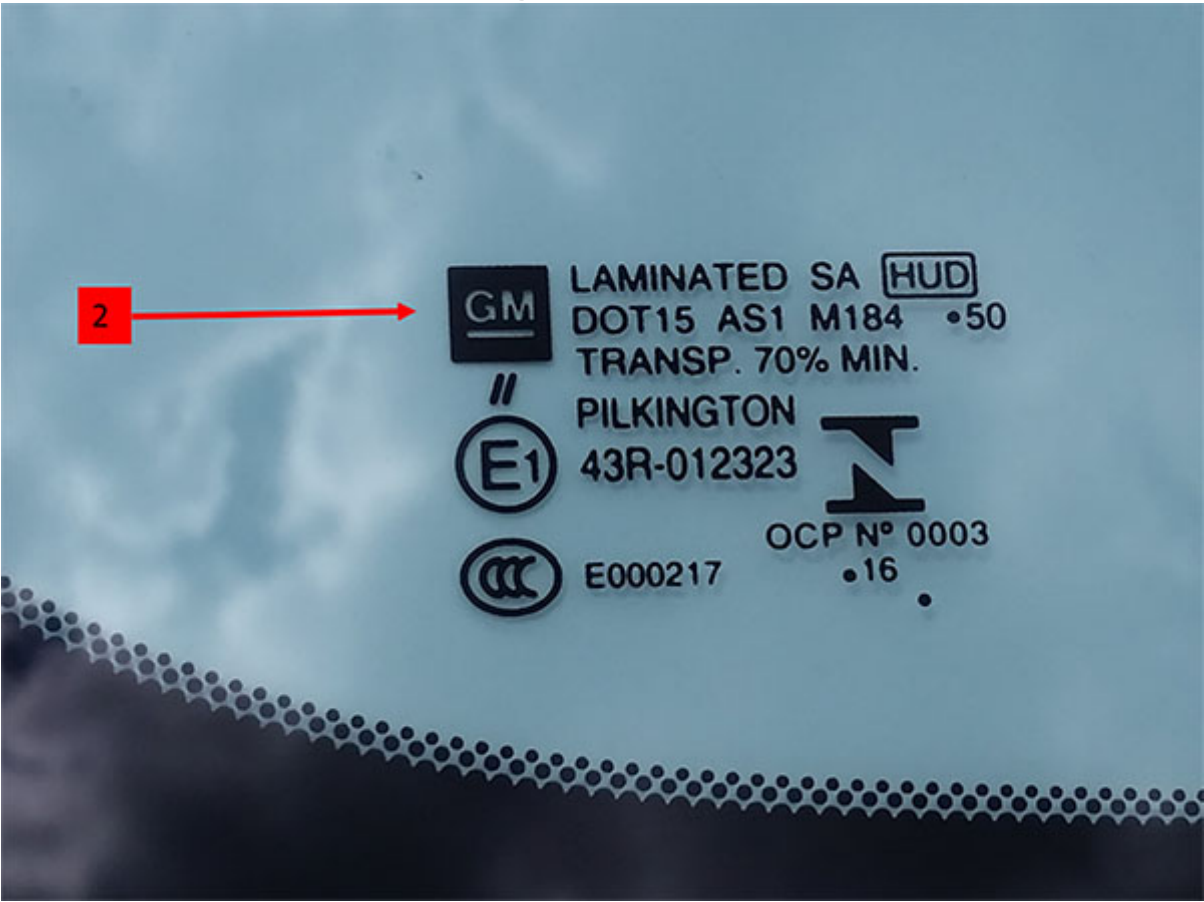
- If, after performing the checks listed above and the root cause of the camera not completing the calibration/learn is still not found, inspect for an aftermarket windshield being installed in the vehicle. To determine whether or not the windshield is an aftermarket or factory windshield, inspect for the "GM" Logo in the lower right corner of windshield, as shown below (2). If the "GM" Logo is not present, then the windshield is aftermarket.

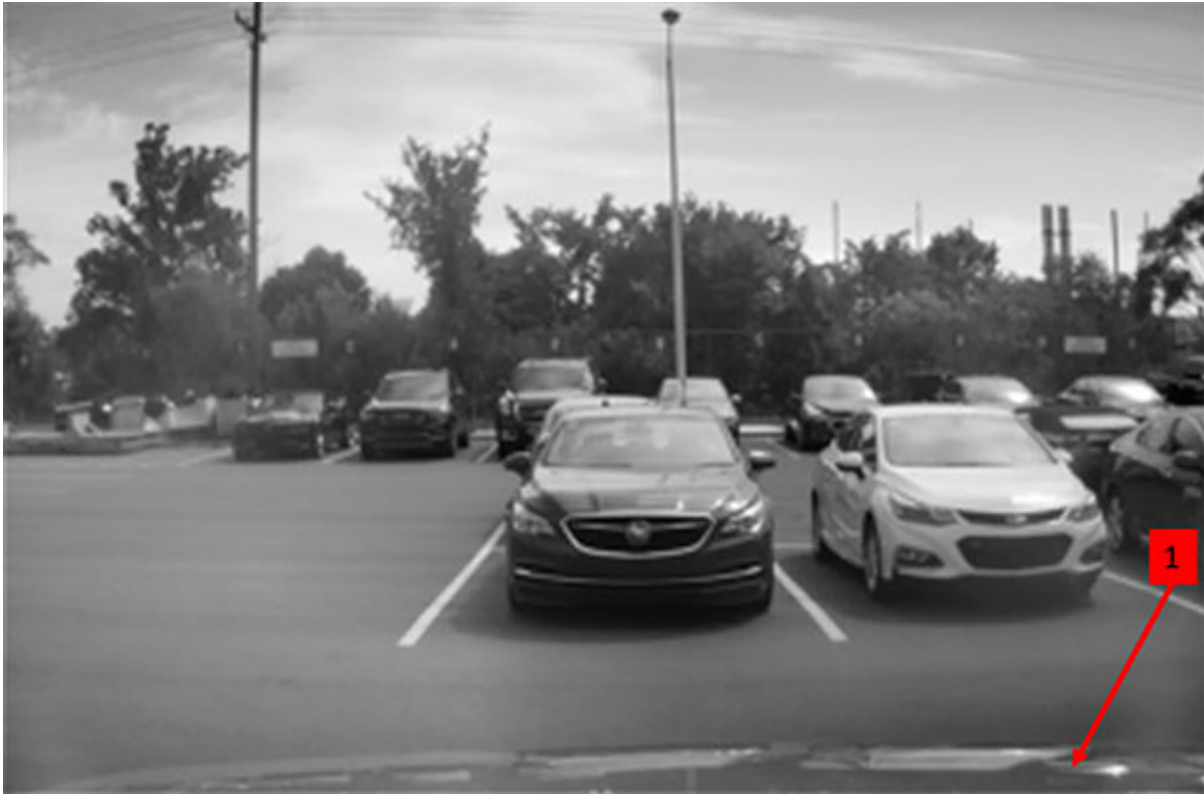
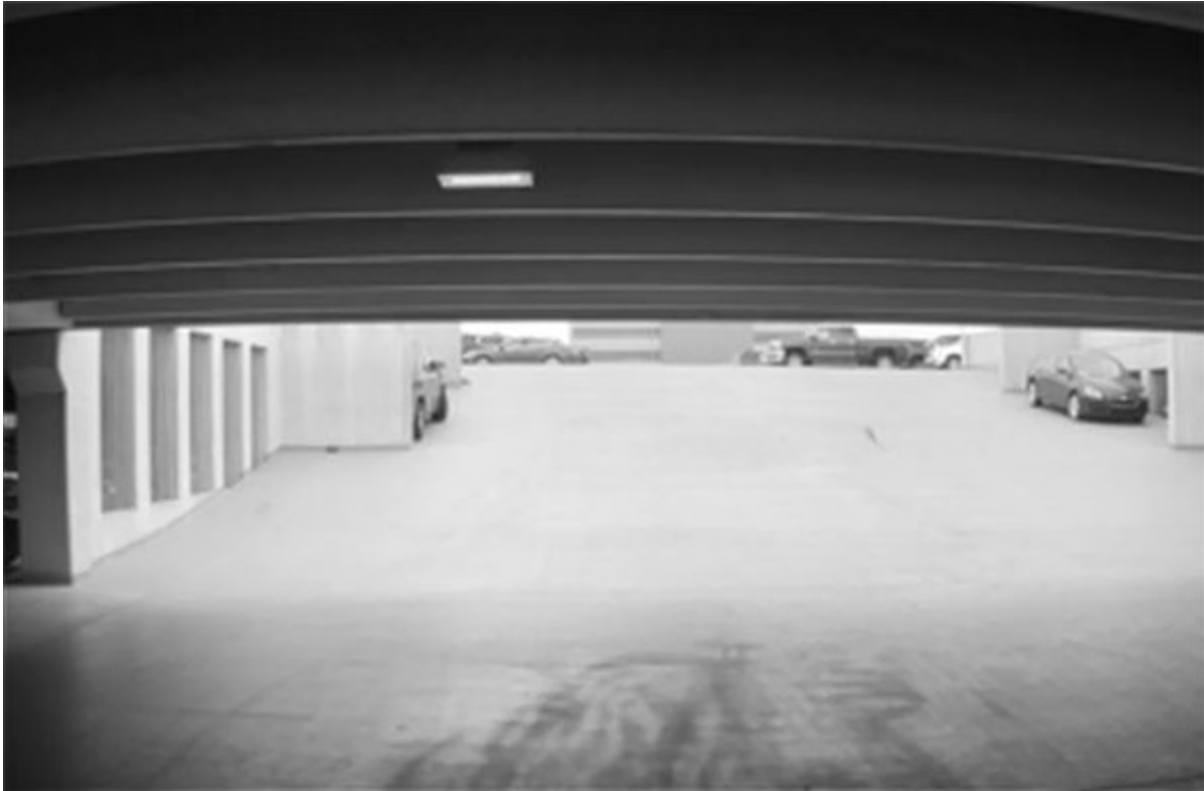
It has been found that some aftermarket windshields do not properly mount/position the front view camera. Shown below are some images, taken with engineering tools (see note below), of what the front view camera is actually seeing. The first image is taken from a truck with an aftermarket windshield. As shown below, the camera is seeing part of the hood (1). Because of this, the camera is not seeing movement in the area of the hood and can not complete the learn. The second image below is from a truck with a factory windshield and there is no hood seen by the front view camera.

NOTE: If the windshield has to be removed/replaced for any of the above reasons, it is suggested that a factory GM windshield be installed.
