### PIP5455C LT4 Supercharger Belt LT1 Accessory Drive Belt Tensioner Noise with A light Tip In AFM

Brand:	Model:	Model Years:	VIN:		Engine:	Transmissions:
			from	to		
Chevrolet	Corvette	2014 - 2018	All	All	6.2L LT1 LT4	All

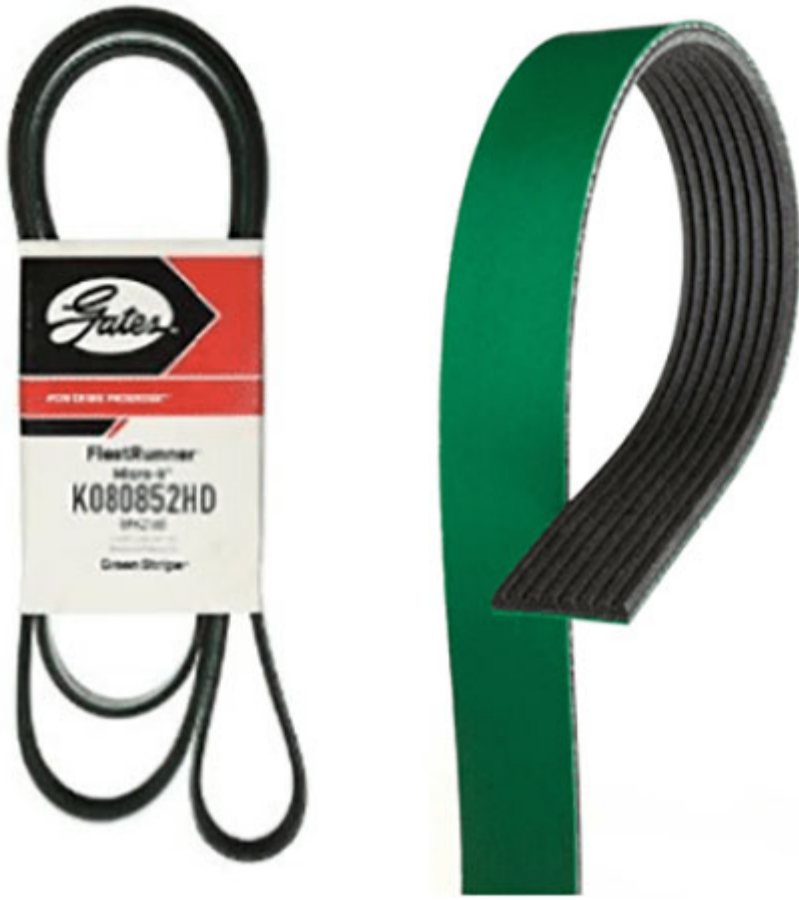
<b>Involved Region or Country</b>	North America
<b>Additional Options (RPO)</b>	LT1 LT4
<b>Condition</b>	<p>There may be a concern with a rattle or flutter noise from the supercharger (LT4) or accessory drive (LT1) tensioner and belt. This occurs in V4 mode with light throttle conditions. Issue sounds like tick noise when in driver seat.</p> <p>This seems to vary between vehicles but replacing the tensioner won't resolve the issue.</p>
<b>Cause</b>	The supercharger (LT4) or accessory drive (LT1) belt tensioner will jump and cause the noise.

Replace the supercharger belt LT4 with a Gates "green" Belt P/N K080852HD to be obtained from local distributor (see pic).

For LT1 accessory drive belt use Gates belt P/N DK060650 (there is not a green belt available).
