## PIP5577 Metal Shavings In The Oil Filter On First Oil Change

### Models

Brand:	Model:	Model Years:	VIN:		Engine:	Transmissions:
			from	to		
Cadillac	CT6	2016 - 2018	All	All	3.0 LGW, 3.6 LGX	All
Cadillac	XT5	2017 - 2018	All	All	3.6 LGX	All
GMC	Acadia	2017 - 2018	All	All	3.6 LGX	All

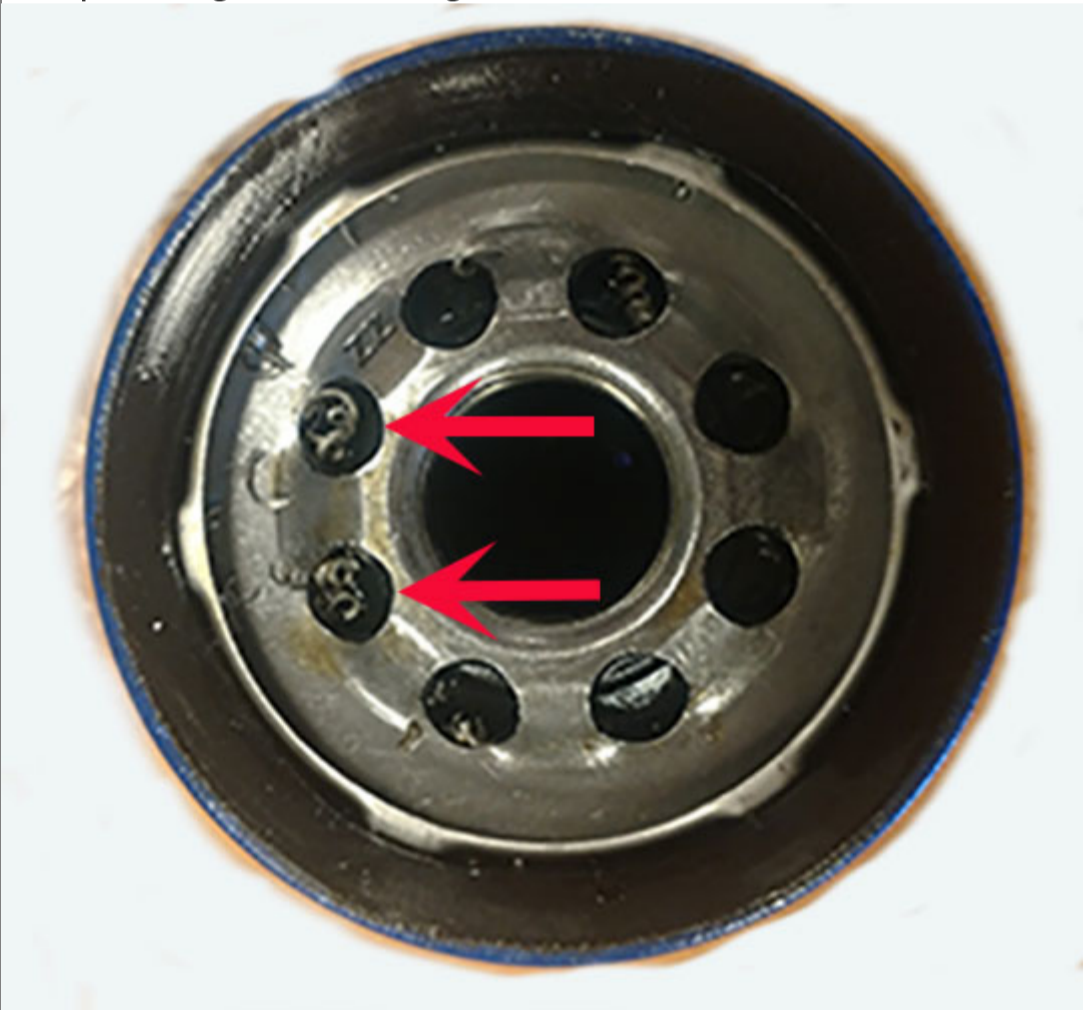
Involved Region or Country	North America
Condition	<p>You may find aluminum metal machining chips or curls on the top of the oil filter when performing the first oil change on a new vehicle.</p>

Cause	These aluminum chips are from the machining process when drilling out the holes for the engine oil cooler.
Correction	<p>This debris is on the intake or dirty side of the oil filter and will not go into the engine.</p> <p><b>NOTE: DO NOT replace the engine because of this debris.</b></p> <p>Change the oil and filter and return the car to the customer.</p>
