Preliminary Information

PIP5402D Check Engine Light MIL P015B, P1101 and /or P0101 Reduce Engine Power

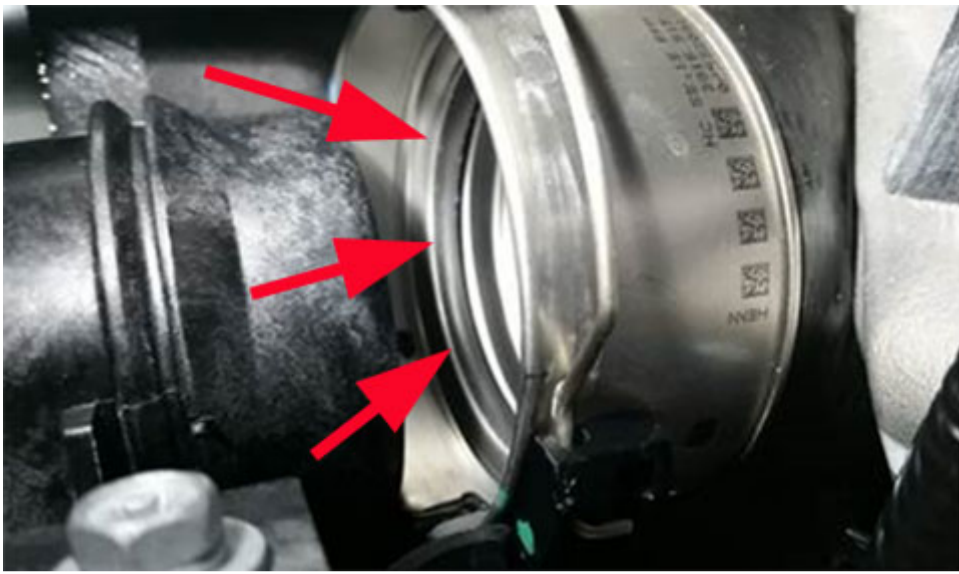
After following normal SI diagnostics, if a solution is not found, inspect for a missing/damaged O-ring seal in the charge air cooler coupler.

This coupler is located on the passenger side of the charge air cooler where the air duct slips into it.

The arrows in the picture below are pointing to the O-ring seal being discussed.

The picture below is from an ATS. Other models are similar.
