Bulletin No.: PIP5487B

PIP5487B 6.6L L5P Duramax Coolant Leaks

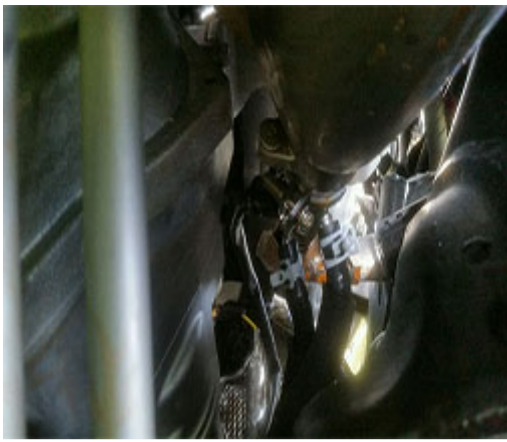
Coolant leaking from coolant hoses at the Emission Reduction Fluid Injector (DEF Injector).
