Preliminary Information

PIP5581 CVT7 shudder concerns. Fluid replacement procedure.

Brand:	Model:	Model Years:	VIN:		Engine:	Transmissions:
			from	to		
Chevrolet	Spark	2014 - 2019	All	All	LL0, LV7	M4M, MR8

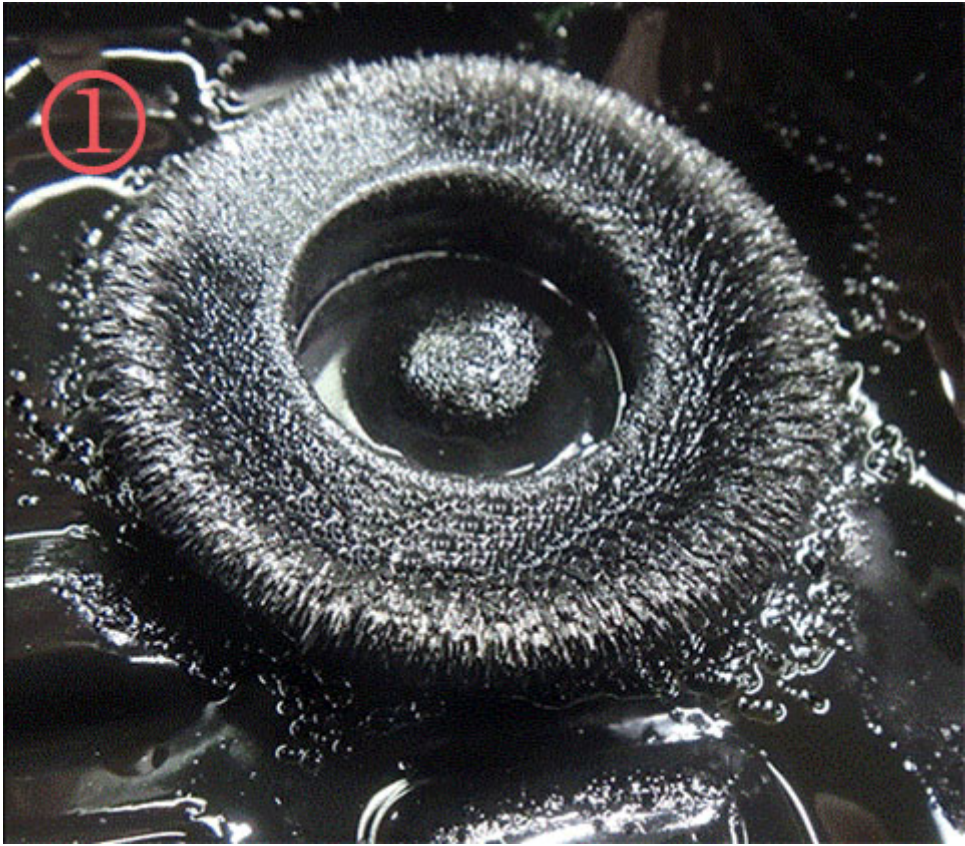
Call out 1
Abnormal debris.

- Step 1. Remove the fluid pan and inspect the magnets for metal debris. Refer to [PIP5548](#) (SI Doc 4955910).
It is normal to have some metallic build up on the magnets.
If the magnets show only the normal magnetic sludge, reinstall the pan using a new gasket if needed.
Per [PIP5548](#), do NOT replace the transmission if metal chips cannot be FELT in the magnetic sludge.

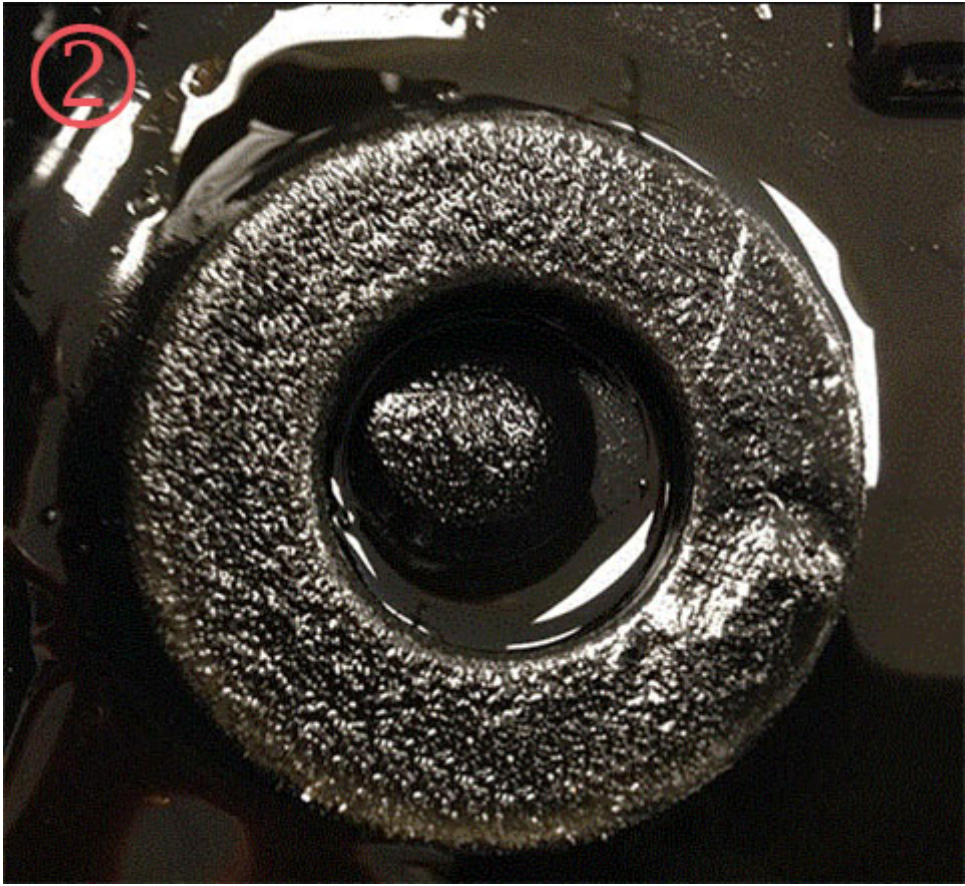
Call out 2
Normal debris.

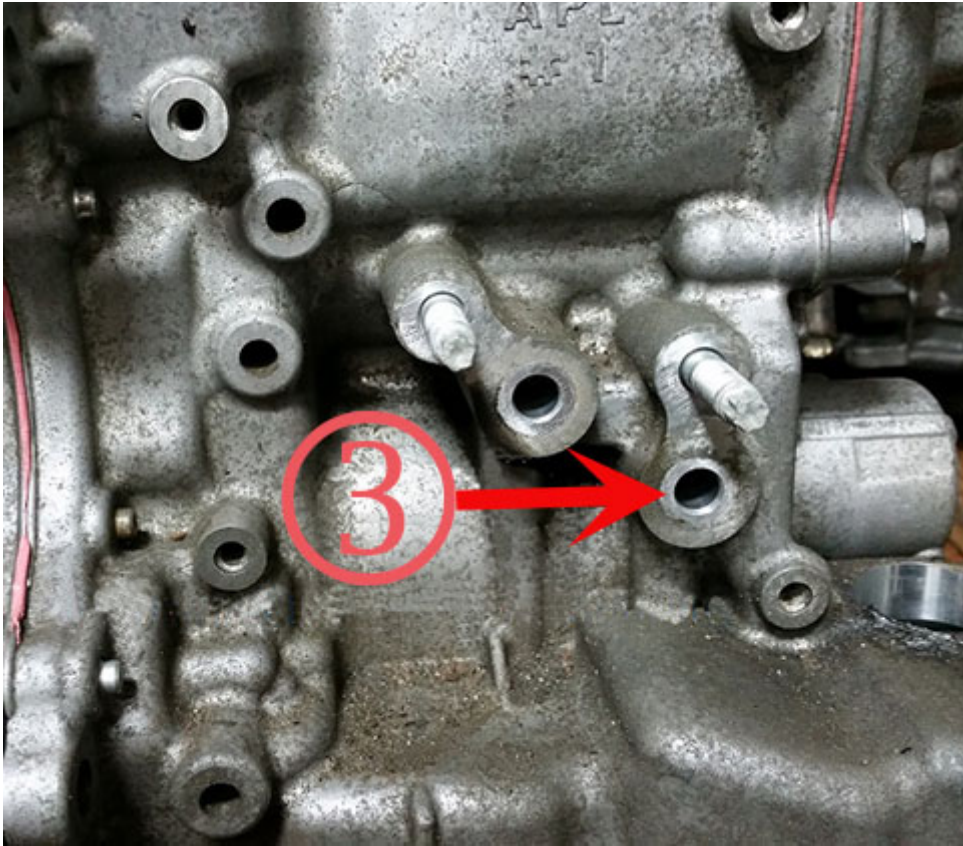
Call out 3
Cooler return port.

Step 3. Disconnect only the transmission cooler return line from the transmission and route it into a suitable container. (The cooler return line connects to the lower port at the transmission.)
