Preliminary Information

PIT5626 Intermittent communications concerns , possible multiple MIL's on , multiple U-codes stored

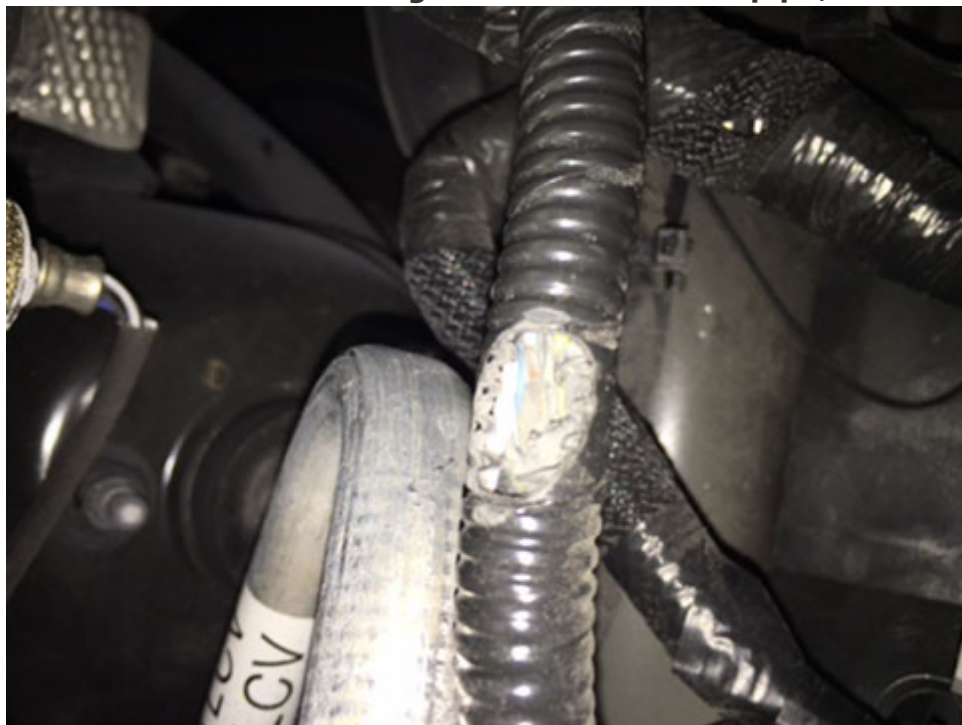
Involved Region or Country:	North America
Additional RPO/s:	LCV
Condition:	Intermittent multiple MIL's or messages, loss of communication, potential U-codes.
Cause:	Main harness chaffed under hood.

Check for harness chaffing on the low side A/C pipe, left side below the exhaust manifold .

Repair per instructions in eSI and secure harness away from the pipe. The plant is investigating the root cause and will put in corrective action.
