Preliminary Information

PIT5600A Dent/Ripple Appearance Around Wheel Well Opening

Brand:	Model:	Model Years:	VIN:		Engine:	Transmissions:
			from	to		
Chevrolet	Colorado	2015 - 2019	All	All	All	All
GMC	Canyon	2015 - 2019	All	All	All	All

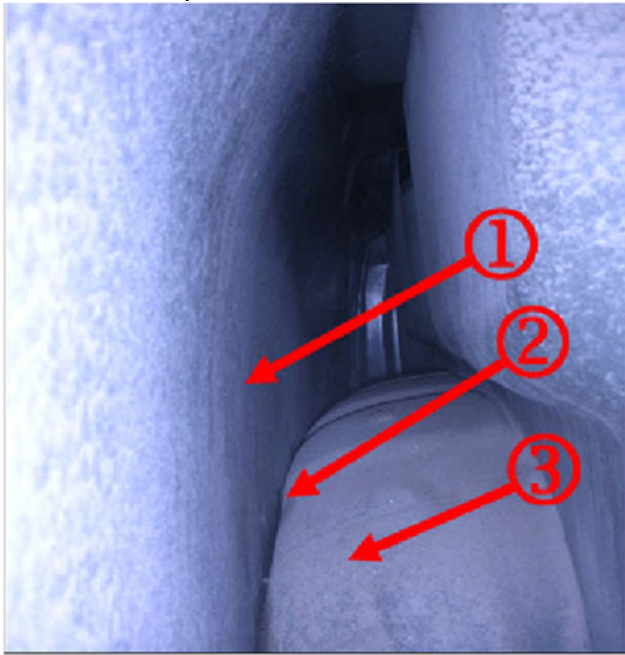
Involved Region or Country:	North America
Additional RPO/s:	N/A
Condition:	Raised dents or ripple appearance in the side outer panel of the cargo box around the perimeter of the wheel house opening.
Cause:	Lodging of stone/aggregate/debris between the wheelhouse, and the side outer panel.

- 1.Remove the tail lamp to access the inner area of the side outer panel above the wheelhouse, see picture below.
2. Inspect for any stone/aggregate/debris. Remove as needed using a power washer and/or shop air blow gun.

4. Access the rear of the inner wheelhouse area through the tail lamp cavity; and the front of the wheelhouse from under the vehicle, and coat the inner hem of the wheel house to side outer panel, with 3M Rust Fighter I, or equivalent, see latest version of 01-08-51-003.

5. Allow sufficient time for this to cure about 5-7 minutes, or according to manufacturer's instructions.
6. Apply several coats of Nox Rust X-121B undercoating or equivalent, from the front and rear.

7. Apply enough undercoating to prevent stone/aggregate/debris from getting between the inner wheel house and side outer panel.
8. Reinstall tail lamp.
