Engine Control Module (ECM) and  
Aftertreatment Control Module (ACM),  
Software Updates  
MP7, MP8  
CHU, CXU, GU, MRU, LR

## **PI0883, Engine Control Module (ECM) and Aftertreatment Control Module (ACM), Software Updates**

(July 2018)

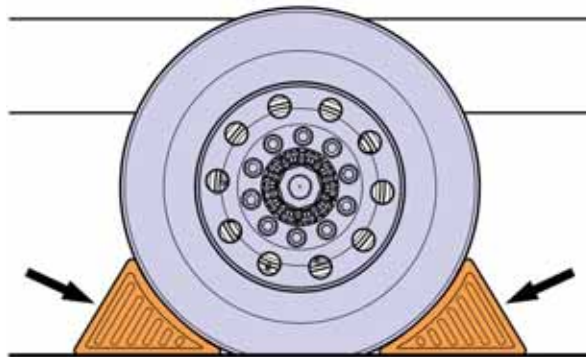
W7086748

- 1 Park the vehicle on a level surface.
- 2 Apply the parking brake.
- 3 Place the transmission in neutral or park.
- 4 Install the wheel chocks.

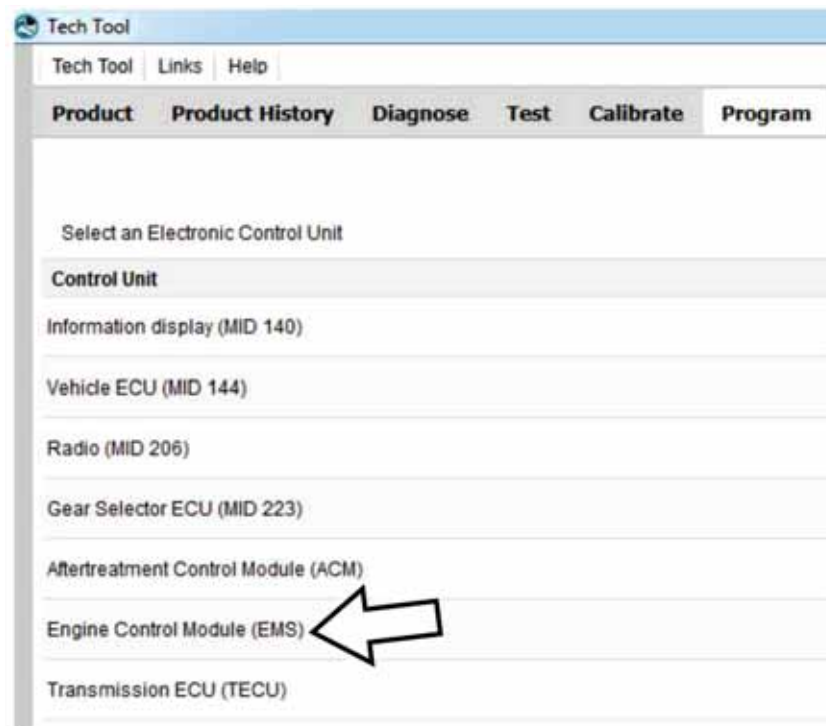
W2115479

11 Select **EMS**.

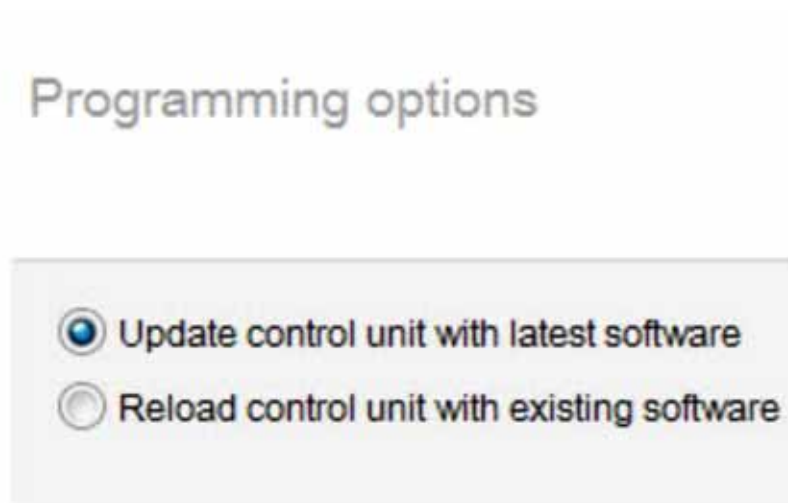
W2115480

12 Select Program to update the **EMS** with the latest software.

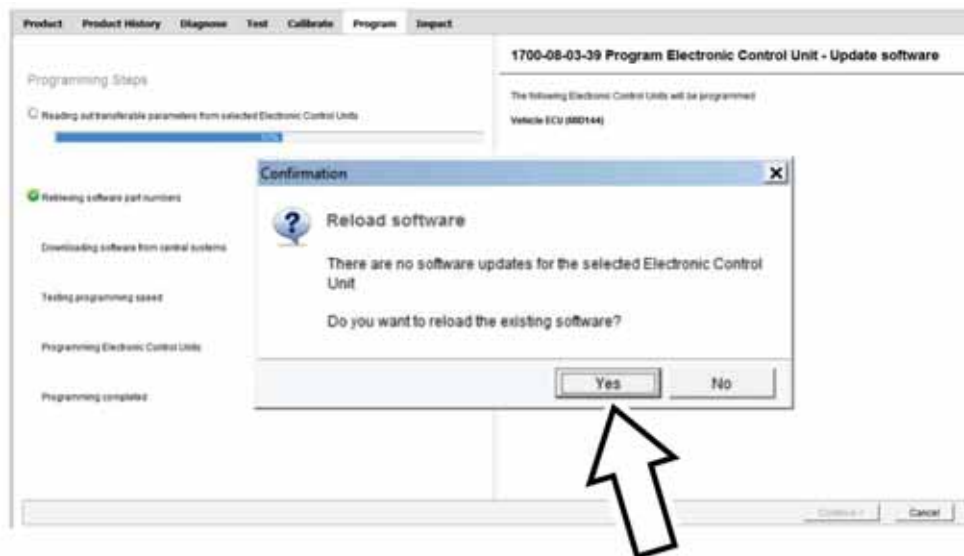
W2115483

- 15 If the software is already updated, this screen opens. Select Yes to reload existing software.

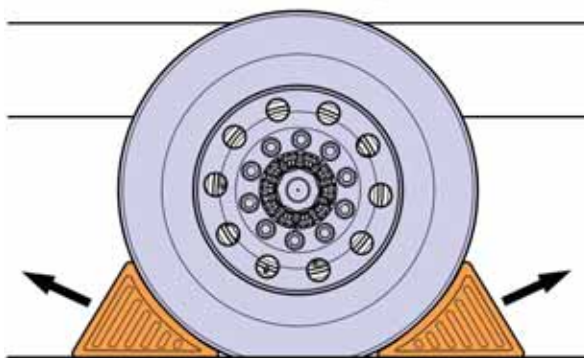
W7086759

- 16 When the programming is complete, clear any diagnostic trouble codes (DTC) and Finish.  
17 When programming is complete, click Exit to return to Main Menu to program the ACM.  
18 When all programming is complete, clear any diagnostic trouble codes (DTC) and Finish Work.  
19 Remove the wheel chocks.
