Engine Control Module (ECM),  
Reprogramming  
Cummins ISL  
GR

## **PI0884, Engine Control Module (ECM), Reprogramming**

**(July 2018)**

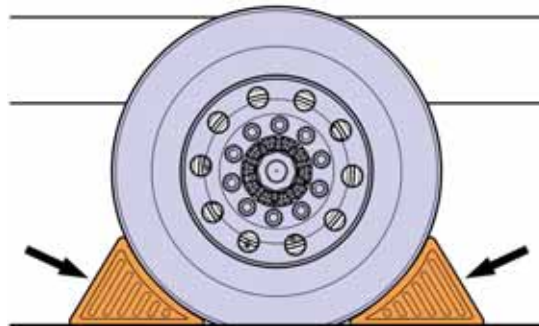
W7086748

- 1 Park the vehicle on a level surface.
- 2 Apply the parking brake.
- 3 Place the transmission in neutral or park.
- 4 Install the wheel chocks.
