SERVICE BULLETIN

Classification: HA18-004a	Reference: NTB18-040a	Date: July 17, 2018
------------------------------	--------------------------	------------------------

2017-2018 TITAN; AIR CONDITIONING BLOWS HOT AIR AFTER EXTENDED IDLING OVER 100°F

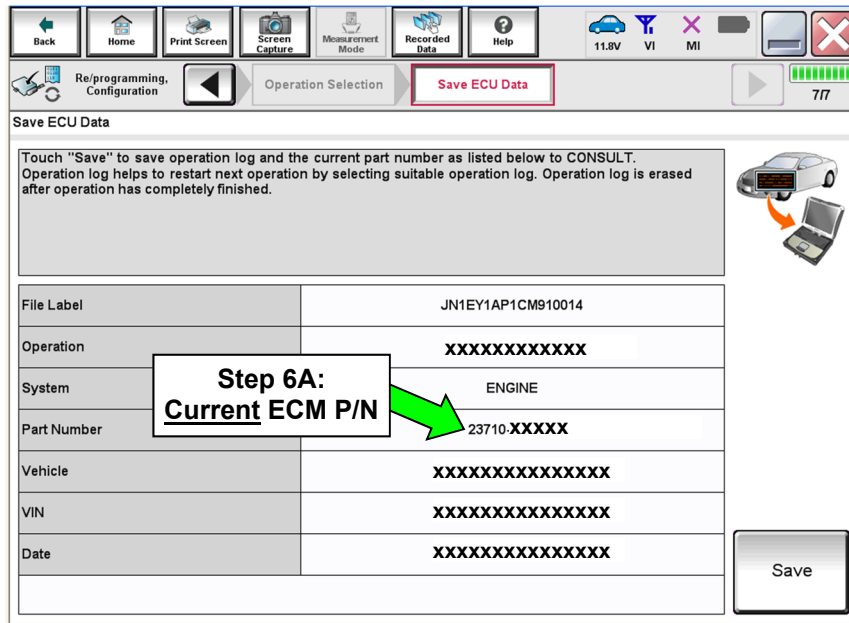
Figure 2

5. Follow the on-screen instructions and navigate C-III plus to the screen shown in Figure 2.
6. When you get to the screen shown in Figure 2, confirm this bulletin applies as follows.
 - A. Find the ECM **Part Number** and write it on the repair order.

NOTE: This is the current ECM Part Number (P/N).

- B. Compare the P/N you wrote down to the numbers in the **Current ECM Part Number** column in **Table A**.
 - If there is a match, continue with the reprogramming procedure.
 - If there is not a match, close C-III plus and refer to ASIST for further diagnostic information.

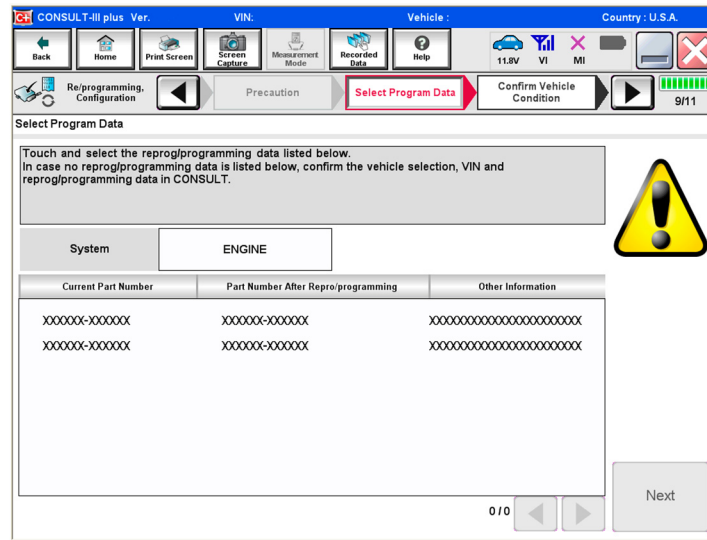
- In some cases, more than one new P/N for reprogramming is available.
 - If more than one new P/N is available, the screen in Figure 3 displays.
 - Select and use the reprogramming option that does **not** have the message “Caution! Use ONLY with NTBXX-XXX”.
- If you get this screen and it is blank (no reprogramming listed), it means there is no reprogramming available for this vehicle. Close C-III plus and refer back to ASIST for further diagnosis.

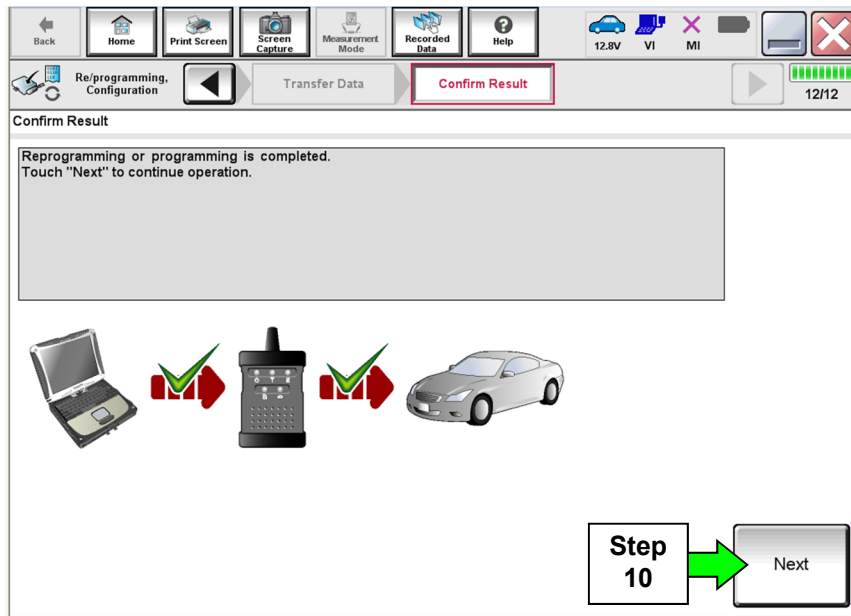
8. When the screen in Figure 5 displays, reprogramming is complete.

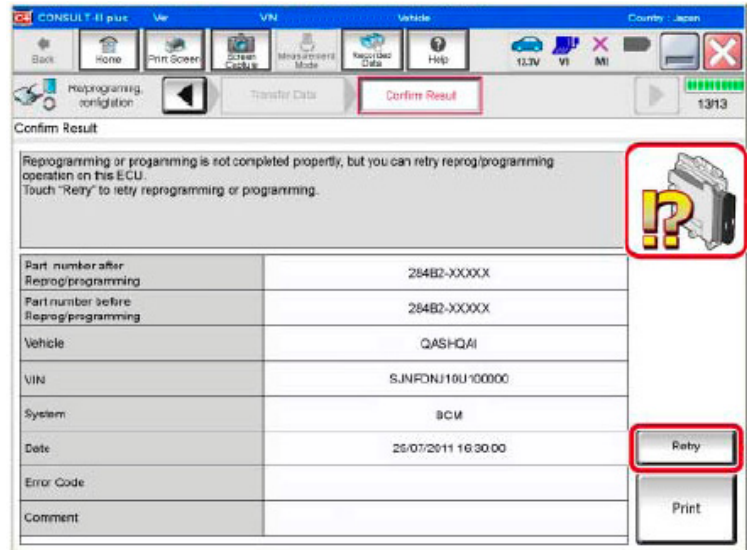
Figure 6

If reprogramming does not complete and the “!?” icon displays as shown in Figure 6:

- Check battery voltage (12.0 - 15.5 V).
- Ignition is ON, engine OFF.
- External Bluetooth® devices are OFF.
- All electrical loads are OFF.
- **Select retry and follow the on screen instructions.**
- **“Retry” may not go through on first attempt and can be selected more than once.**

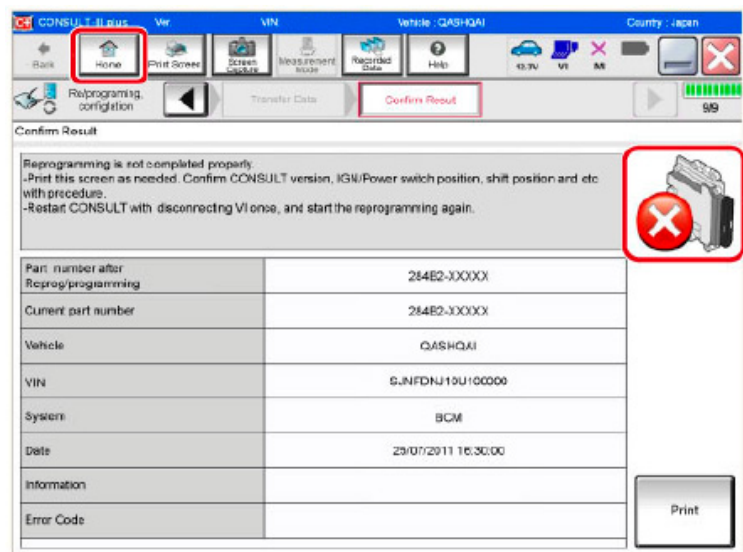
Figure 7

If reprogramming does not complete and the “X” icon displays as shown in Figure 7:

- Check battery voltage (12.0 - 15.5 V).
- CONSULT A/C adapter is plugged in.
- Ignition is ON, engine OFF.
- Transmission is in Park.
- All C-III plus / VI cables are securely connected.
- All C-III plus updates are installed.
- **Select Home, and restart the reprogram procedure from the beginning.**

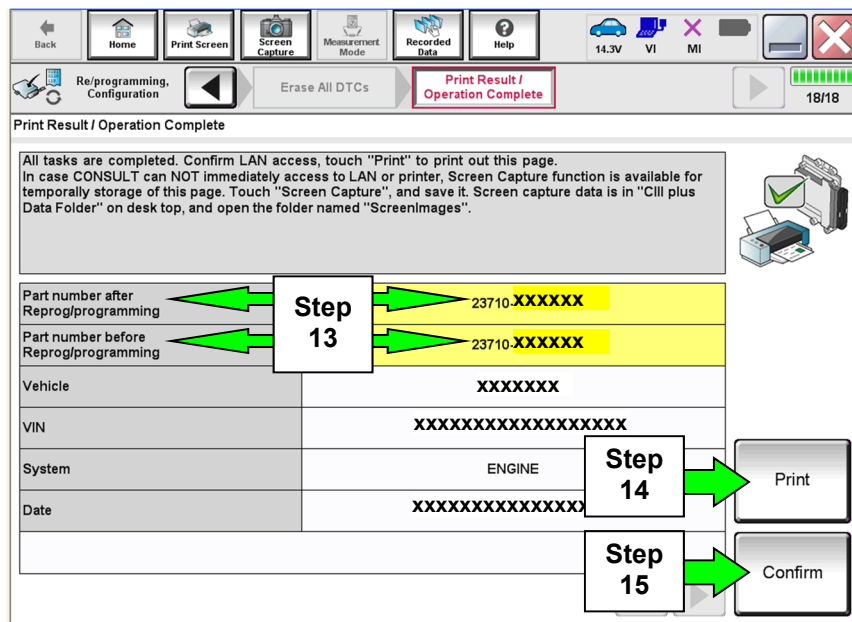
12. When the entire reprogramming process is complete, the screen in Figure 8 will display.
13. Verify the before and after part numbers are different.
14. Print a copy of this screen (Figure 8) and attach it to the repair order for warranty documentation.
15. Select **Confirm**.
