# SERVICE CAMPAIGN BULLETIN

NTB18-048

## VOLUNTARY SERVICE CAMPAIGN 2013-2017 ALTIMA ENGINE CONTROL MODULE REPROGRAM

**CAMPAIGN ID #:** PC633  
**APPLIED VEHICLES:** 2013-2017 Altima (L33)  
**APPLIED ENGINE:** QR25DE (4 cylinder engine)

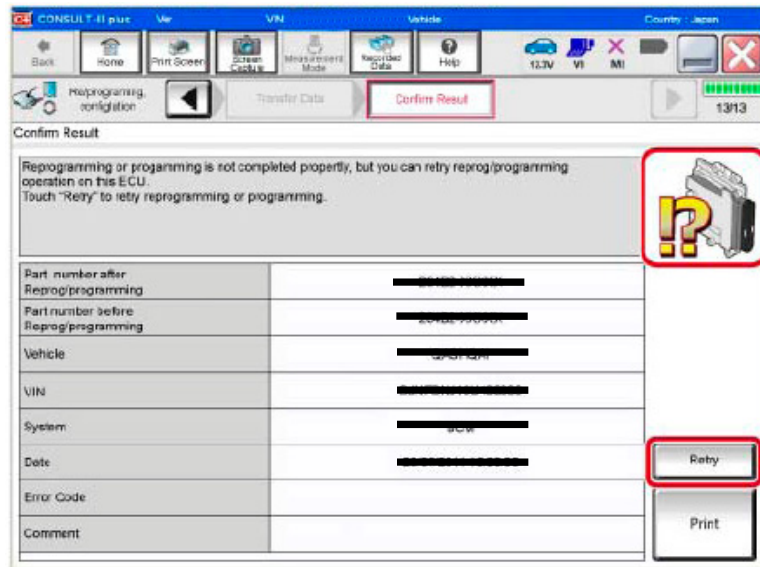
Figure 6

If reprogramming does not complete and the “!?” icon displays as shown in Figure 6:

- Check battery voltage (12.0–15.5 V).
- Ignition is ON, engine OFF.
- External Bluetooth® devices are OFF.
- All electrical loads are OFF.
- **Select retry and follow the on screen instructions.**
- “Retry” may not go through on first attempt and can be selected more than once.

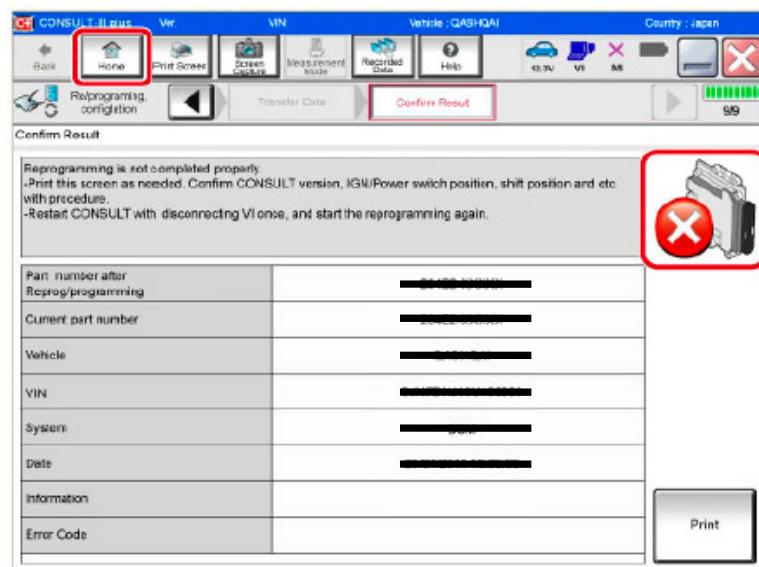
Figure 7

If reprogramming does not complete and the “X” icon displays as shown in Figure 7:

- Check battery voltage (12.0 – 15.5 V).
- CONSULT A/C adapter is plugged in.
- Ignition is ON, engine OFF.
- Transmission is in Park.
- All C-III plus / VI cables are securely connected.
- All C-III plus updates are installed.
- **Select Home, and restart the reprogram procedure from the beginning.**
