SERVICE CAMPAIGN BULLETIN

NTB18-050

VOLUNTARY SERVICE CAMPAIGN 2014 – 2017 ROGUE; ECM REPROGRAM

CAMPAIGN ID #: PC633 (VINs starting with 5N or JN)
P8325 (VINs starting with KN)
APPLIED VEHICLES: 2014 – 2017 Rogue (T32)
APPLIED ENGINE QR25DE

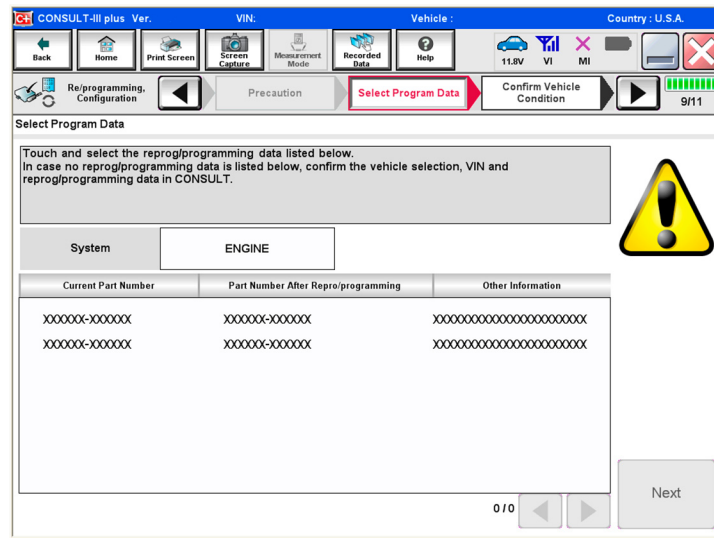
- In some cases, more than one new P/N for reprogramming is available.
 - In this case, the screen in Figure 3 displays.
 - Select and use the reprogramming option that **does not** have the message “Caution! Use ONLY with NTBXX-XXX”.
- If you get this screen and it is blank (no reprogramming listed), it means there is no reprogramming available for this vehicle.

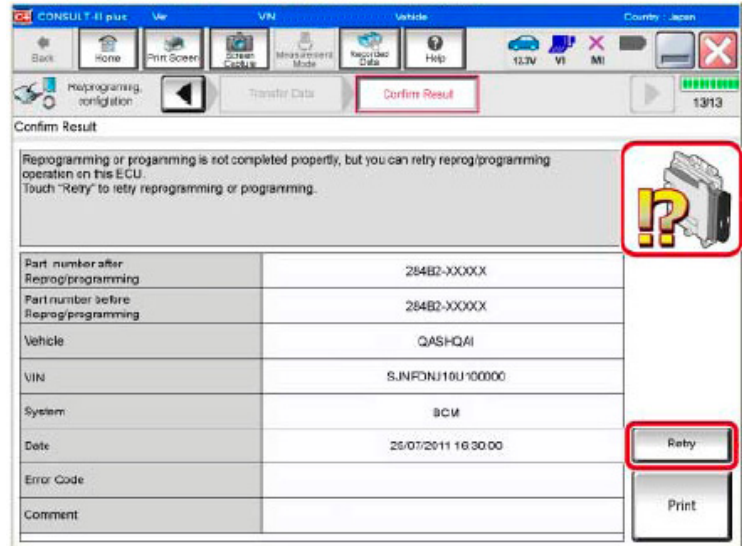
Figure 6

If reprogramming does not complete and the “!?” icon displays as shown in Figure 6:

- Check battery voltage (12.0 - 15.5 V).
- Ignition is ON, engine OFF.
- External Bluetooth® devices are OFF.
- All electrical loads are OFF.
- **Select retry and follow the on screen instructions.**
- “Retry” may not go through on first attempt and can be selected more than once.

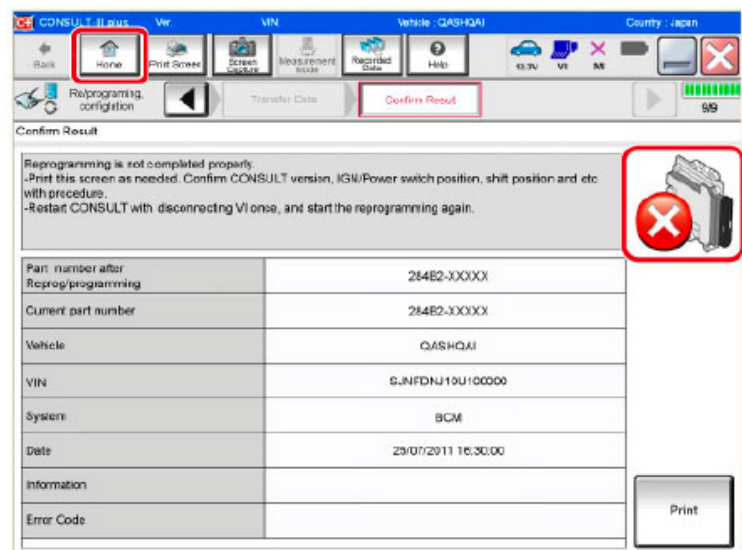
Figure 7

If reprogramming does not complete and the “X” icon displays as shown in Figure 7:

- Check battery voltage (12.0 - 15.5 V).
- CONSULT A/C adapter is plugged in.
- Ignition is ON, engine OFF.
- Transmission is in Park.
- All C-III plus / VI cables are securely connected.
- All C-III plus updates are installed.
- **Select Home, and restart the reprogram procedure from the beginning.**
