SERVICE CAMPAIGN BULLETIN

NTB18-051

VOLUNTARY SERVICE CAMPAIGN 2013-2017 SENTRA; ECM REPROGRAM

CAMPAIGN ID #s: PM827 and PC633
APPLIED VEHICLES: 2013-2017 Sentra (B17)
APPLIED ENGINE: MRA8DE (non-turbo)

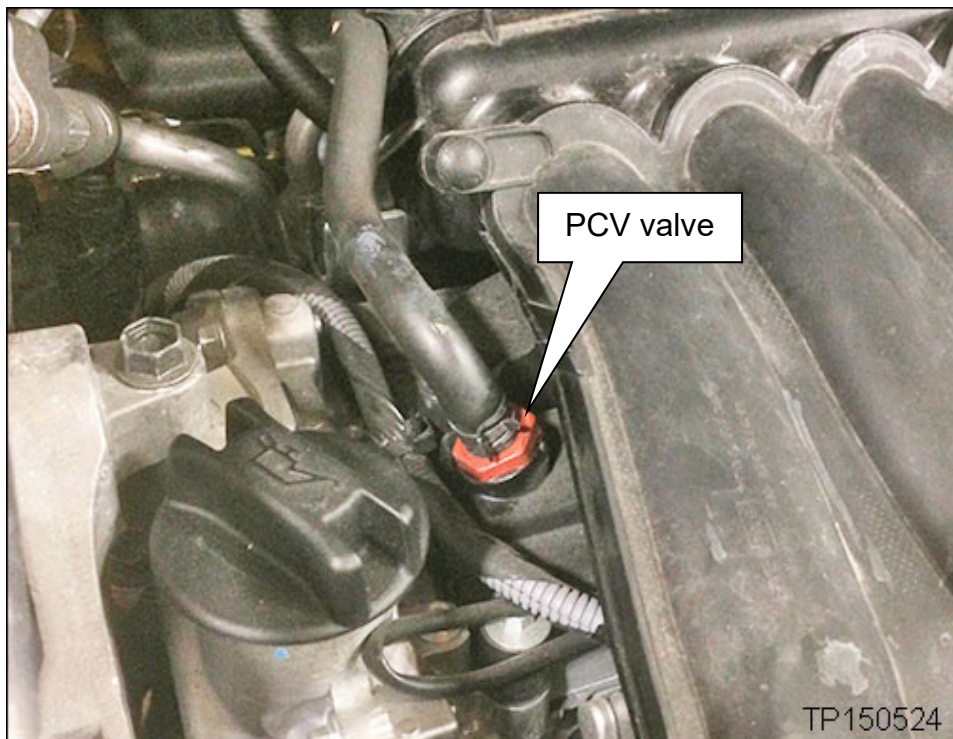
Figure A

If the PCV valve is orange, as shown in Figure A:

- Replace the PCV valve.
- If needed, refer to the Electronic Service Manual (ESM), section EM-Engine Mechanical, for replacement information.
- Use the new PCV valve listed in the Parts Information.
- The new PCV valve is “black” color.

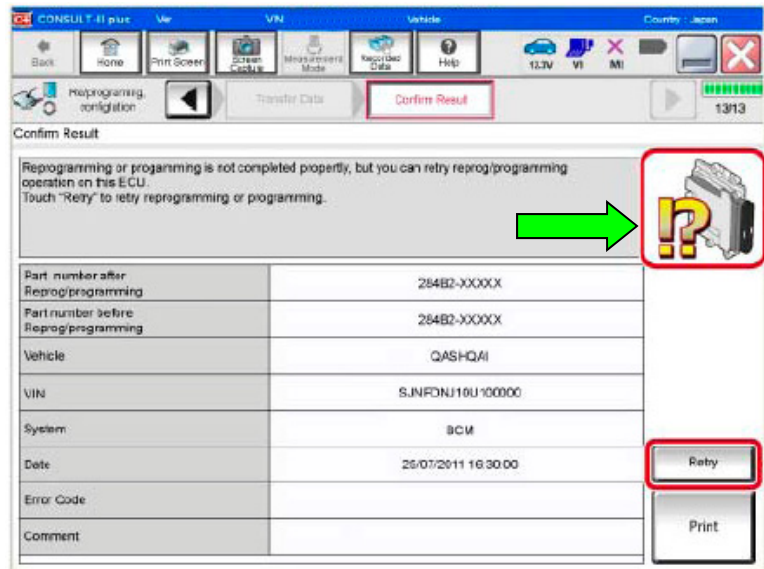
Figure 6

If reprogramming does not complete and the “!” icon displays as shown in Figure 6:

- Check battery voltage (12.0–15.5 V).
- Ignition is ON, engine OFF.
- External Bluetooth® devices are OFF.
- All electrical loads are OFF.
- **Select retry and follow the on screen instructions.**
- “Retry” may not go through on first attempt and can be selected more than once.
