SERVICE BULLETIN

Classification: EM10-007c	Reference: NTB10-104c	Date: July 31, 2018
------------------------------	--------------------------	------------------------

TITAN, ARMADA, NV; ENGINE OIL LEAK AT RIGHT SIDE BLOCK BALL PLUG

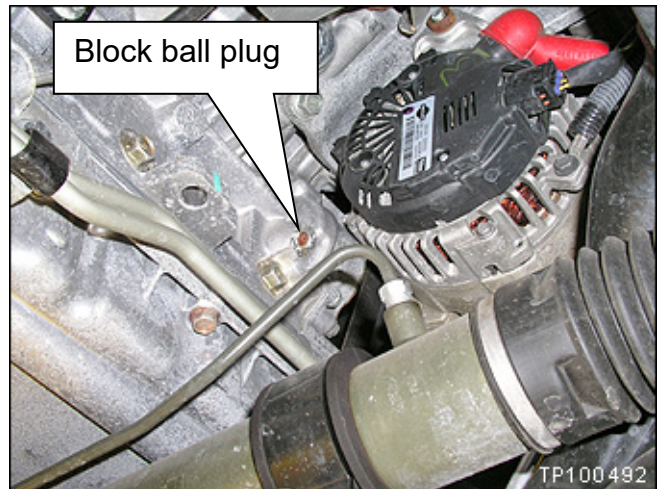
Figure 1

An oil leak at the right side block ball plug behind the alternator.

Use a punch to seat the block ball plug in the hole (refer to the Service Procedure).

NOTE: Do not replace the engine block for this incident, if it should occur.
