Symptom in Vehicle Interior - Wind Deflector/Convertible Top Does Not Close: Reworking Hall Sensor (SY 11/16)

Model Year: **As of 2014 up to 2015 - 911 (991)**

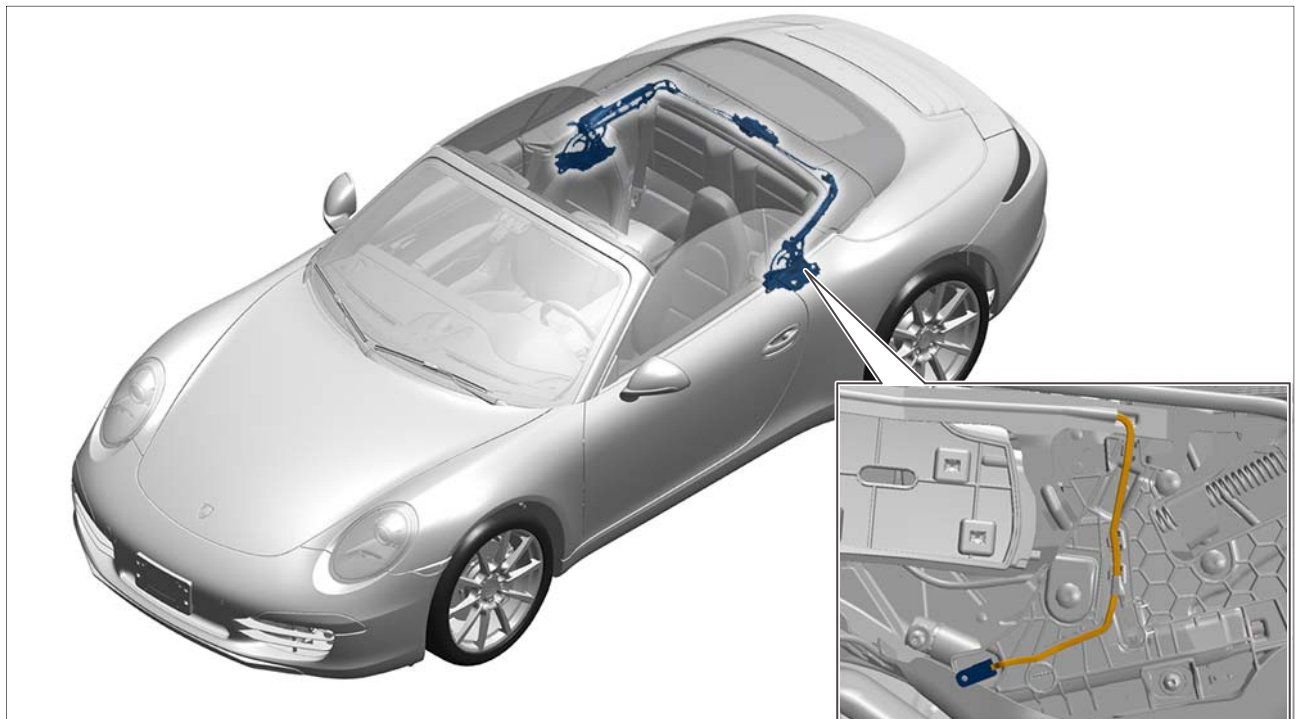
Installation position of Hall sensor for wind deflector

Cause If the Hall sensor is not positioned correctly or if it becomes slightly detached, there will be too much of a gap between the sensor and component and an error message will be displayed.

A defined gap between the Hall sensor and component must be observed. The Hall sensor is bonded at the defined position and is also held in position with a fixing clip.
