Symptom in Vehicle Interior - Airbag Warning Light in the Instrument Cluster Comes On (without I-no. 899): Reworking electric wire harness (SY 73/18)

Model Lines: **911 Carrera (991)**

718 Boxster/718 Cayman (982)

Subject: **Airbag switch**

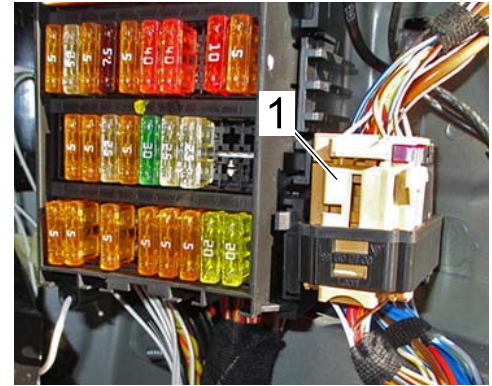
(Connection point (TSX5))

Cause: Corrosion at the connection point (TSX5) in the passenger footwell can cause the airbag warning light in the instrument cluster to come on.

- 2.1 Release and disconnect electric plug connection ⇒ *(Connection point (TSX5))-1-*.
