Front Air Lift Strut Leaks

Model	Model Year	Model Type	VIN Range	Vehicle-Specific Equipment
911 GT3; 911 GT3 RS	2014 - 2018	991	N/A	I option 474 Front Axle Lift

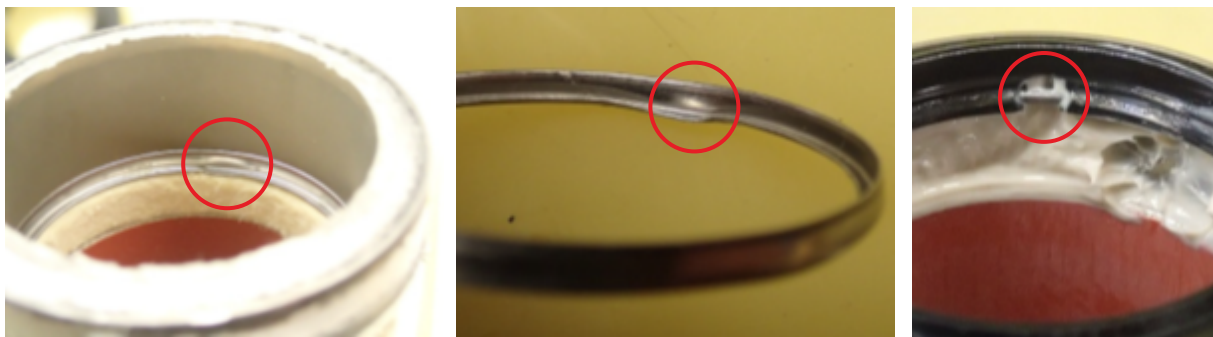
The front strut leaks air. A tool with minor damage at the supplier was causing minor damages to struts during production.

The front strut(s) can be replaced. The parts inventory has been purged. All new parts in the supply system are known good parts after July 5, 2018.
