Paint Bubbles in Carbon Fiber Parts

Model	Model Year	Model Type	VIN Range	Vehicle-Specific Equipment
911 Turbo S	2018	991	N/A	N /A
911 GT2 RS	2018	991	N/A	N/A

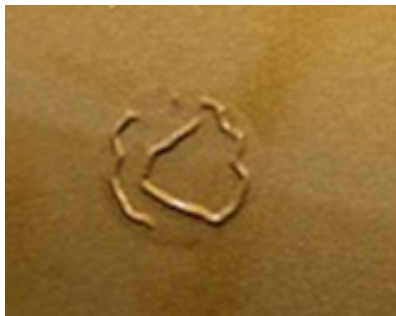
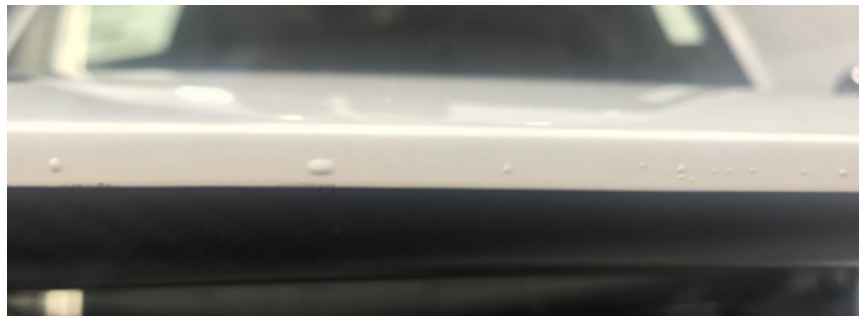
Customer complains of bubbles in the paint on carbon fiber parts.

Bubbles are caused by contamination during the paint process.

There is no paint repair solution. The carbon fiber components with the issue must be replaced.
