**Cayenne AC Evaporator Drains Clogging**

Model	Model Year	Model Type	VIN Range	Vehicle-Specific Equipment
Cayenne	2014 - 2017	92A	N/A	N /A

Revision	Release Date	Changes
0	July 11, 2018	Original document

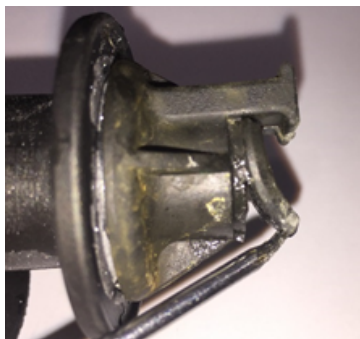
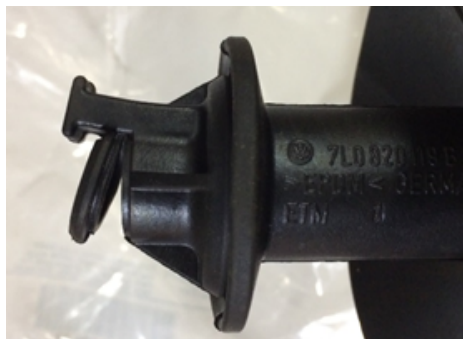
Customer complains of water in the floorboard and/or a musty smell in the vehicle. The air conditioner evaporator drain is clogged. Water backs up in the AC plenum and overflows into the vehicle interior.

The issue is caused by incomplete cutting of the drain flap at the parts supplier. When the flap is not cut all the way back, it is not able to open fully. The drain will clog.

A new drain may be installed. It is also possible to complete the cut on the drain flap so the flap opens fully. The drain should then be cleaned and reinstalled.
