SERVICE BULLETIN

APPLICABILITY: 2017-2018MY Impreza
2018MY Crosstrek

NUMBER: 05-62-18

SUBJECT: Surface Rust Accumulation in Front Strut Mounts

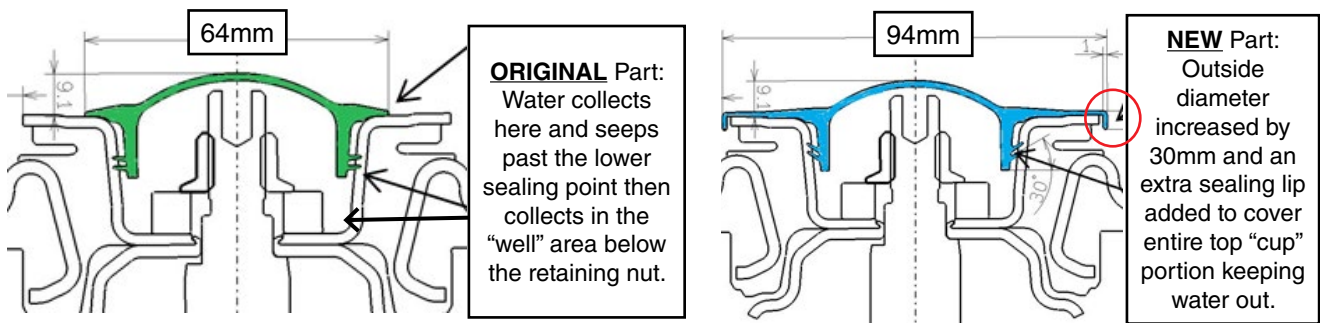
This bulletin provides a procedure to address customer concerns of surface rust accumulating in the top center retaining nut area of the front strut mounts. The strut mount cap / seal shape has been changed (outside diameter increased by 30mm) and reinforced to provide improved sealing against water intrusion. **NOTE:** Any rust accumulation as described here is cosmetic and will not impair functionality of the strut top.

The part number for the new “DUST SEAL-FRONT STRUT” is: **20326FL001**.
