## SERVICE BULLETIN

**APPLICABILITY:** 2013-2018MY BRZ  
**SUBJECT:** Ball Joint Boots Cracking

**NUMBER:** 05-65-18  
**DATE:** 07/31/18

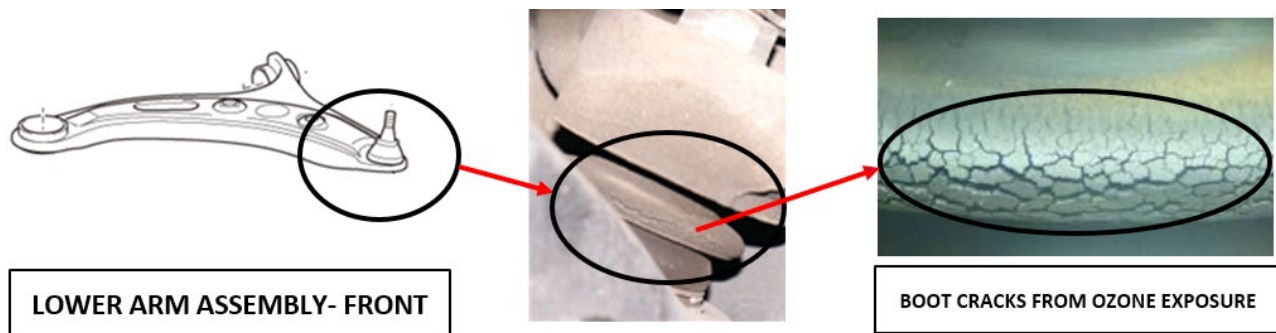
This bulletin announces a change made to the front lower control arm ball joint boots. The boot material has been changed to provide increased resistance to damage from ozone as shown below.

New lower arm assemblies with the improved ball joint boots were incorporated into production starting with VIN **J8602482**.

Description	Part Number
LOWER ARM ASSEMBLY-FRONT RIGHT	20202CA001
LOWER ARM ASSEMBLY-FRONT LEFT	20202CA011

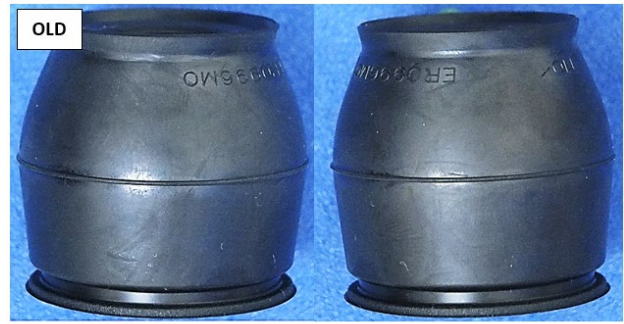
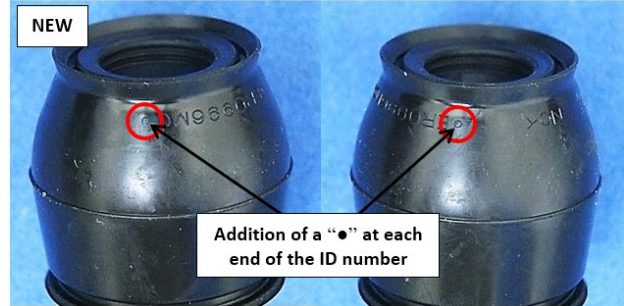
Comparison Between **NEW** and **OLD** Boot:  
 Before Change (**OLD**): ER0996MO  
 After Change (**NEW**): ●ER0996MO●

- The arm assembly must be replaced as the boot and / or ball joint are not available separately.
- The lower arm to crossmember nut and bolt along with the support plate retaining nut and bolt must be replaced as they are all **one-time use** items.
- It is NOT necessary to replace the lower arm assemblies in pairs.
- Always refer to the applicable Subaru Service Manual for related inspection procedures as part of any diagnosis.
