## SERVICE BULLETIN

**APPLICABILITY:** 2014-17MY Forester Turbo **NUMBER:** 07-136-18  
**SUBJECT:** New Alternator Assembly to Address Engine Vibration at Idle and False DTCs P0300, P0301, P0302, P0303 and P0304 **DATE:** 07/18/18

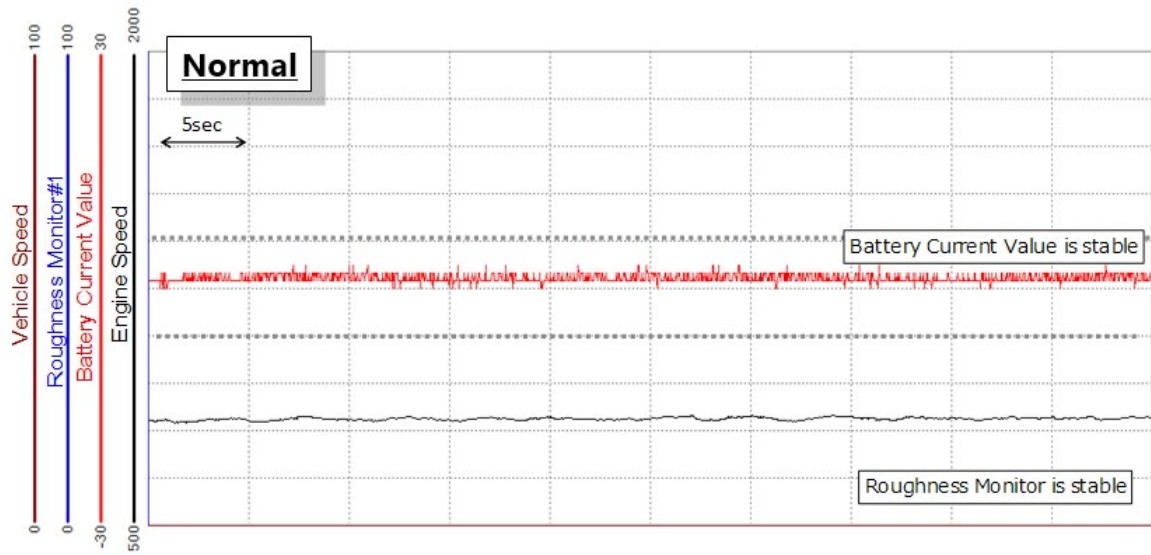
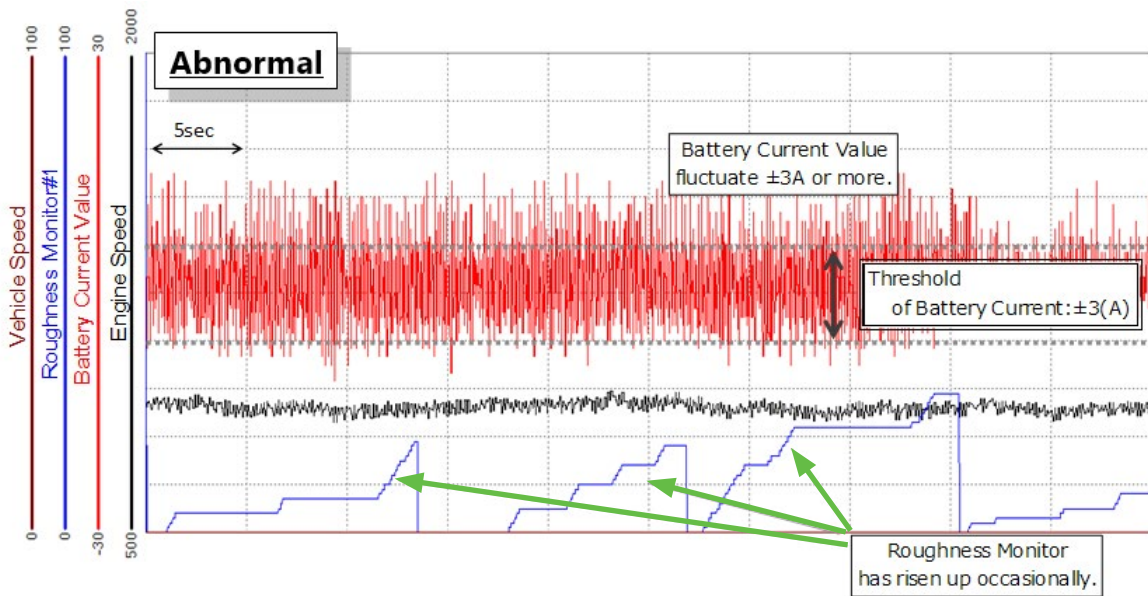
The reference illustrations below show examples of “Normal” and “Abnormal” SSM4 data.

The abnormalities shown above for the Roughness Monitor and Battery Current Value are a result of resonance originating in the alternator pulley and tensioner assemblies. Although any of the listed DTCs may set, there is not an actual misfire of the engine.

When determined necessary to replace the alternator, tensioner and v belt, follow the procedure in the applicable Service Manual.
