SERVICE BULLETIN

APPLICABILITY: 2015-2018MY Legacy and Outback NUMBER: 12-246-18

SUBJECT: "Popping" or "Snapping" Sound When

Opening the Sunroof

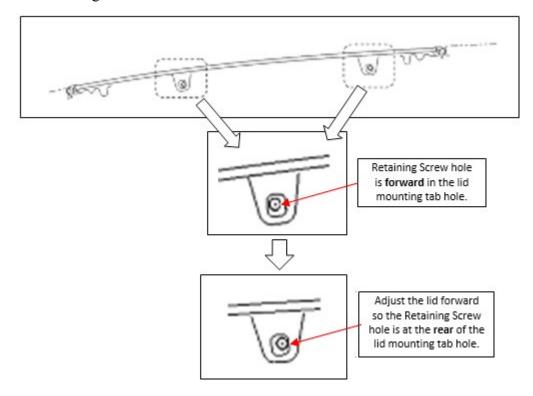
Step 1: Adjust the lid forward to reduce chances of the weatherstrip sticking or catching the edge of the sunroof opening in the roof panel or the sunroof frame. This can cause the snapping sound and / or damage to the weatherstrip / seal..

1a- Loosen the retaining screws and move the lid forward as shown below.

1b- Adjust the surface fitting of the lid to the roof panel, 1mm up from flush along the front edge and 1mm below flush along the rear edge.

1c- Tighten the screws and re-check sunroof operation.

NOTE: If completion of these **Step 1** adjustments has repaired the condition, replace the 4 lid retaining screws ONE AT A TIME (to retain the adjustment) with NEW screws and torque to 40 inch-pounds.

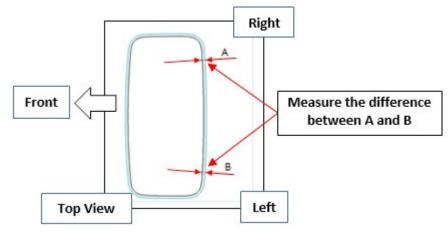
2a- Check and measure for a difference in the amount of deformation of the weather-strip.

If there is a difference between **A** and **B**, go to **2b** and **CAREFULLY** follow the adjustment procedure. If there is no difference, proceed to **Step 4**.
