NUMBER: 12-247-18

SERVICE INFORMATION BULLETIN

APPLICABILITY:	2017-2018MY Impreza 5-Door 2017-2018MY Crosstrek
SUBJECT:	Cargo Cover Installation Reminder

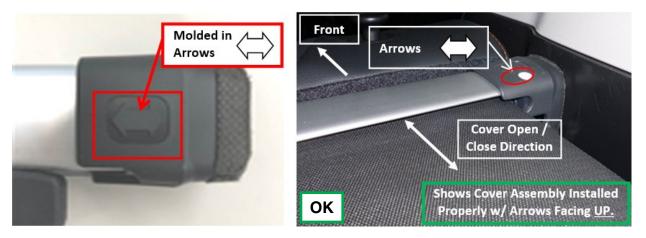
• Correct Installation:

The outlet for the cover on the housing faces the back of the car.

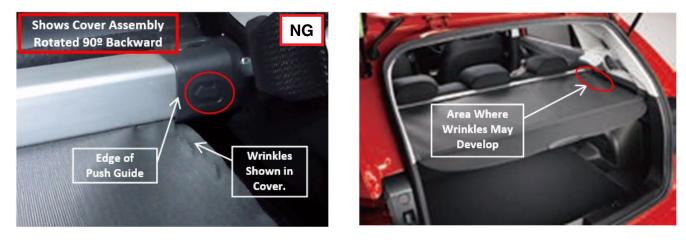
• Incorrect Installation:

If the housing is rotated 90 degrees and installed that way, the outlet for the cover will point downward toward the floor. If this occurs, the cover material may get caught in the push guide area and cause wrinkles or other damage.

On the right side (spring-loaded) end cap portion of the housing, there is a double-ended arrow image molded into the plastic to represent how to move the cover assembly laterally to remove / install it. It is critical for the arrows to face upward for proper operation of the cover assembly and to prevent wrinkling or damaging the cover material.

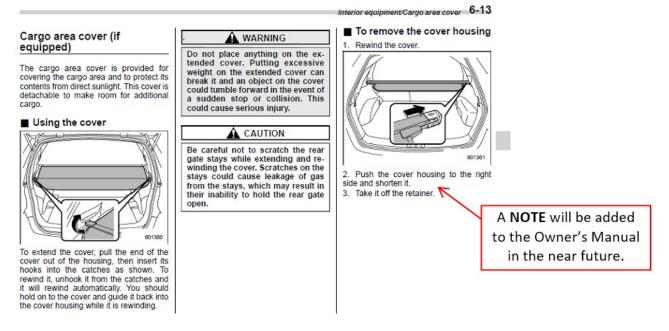
This Service Information bulletin serves as a reminder to always make sure the rear cargo cover (a.k.a. Tonneau Cover) is re-installed properly after removal. Although the cover fits and operates if not installed properly, wrinkling and / or damage to the cover material can occur as shown in the images below.
