SERVICE BULLETIN

APPLICABILITY: 2017-18MY Impreza
 2018MY Crosstrek
 2018MY Legacy and Outback
 2018MY BRZ

NUMBER: 15-211-17R
DATE: 06/13/17
REVISED: 07/25/18

SUBJECT: Reprogramming File Availability for Additional Optimization of Harman Gen 3 Audio and Navigation Head Units

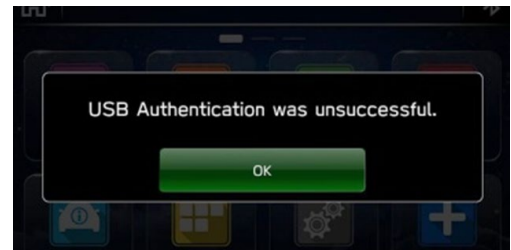
CAUTION: NEVER attempt to install this software on any 2019 MY vehicles as they are equipped with Gen 3.1 Audio/ Navigation systems. This update is ONLY for models equipped with Gen 3.0 Audio/ Navigation systems. Should an attempt be made to install any of these files into a Gen 3.1 head unit, the authentication error screen to the right will be displayed.

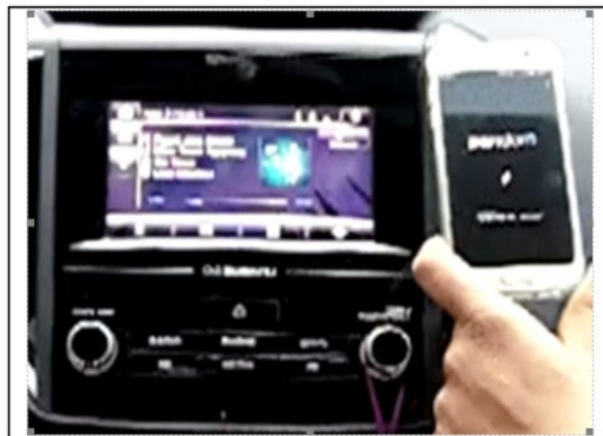
- 1- No streaming audio. When using the Pandora® app, there is no audio output.

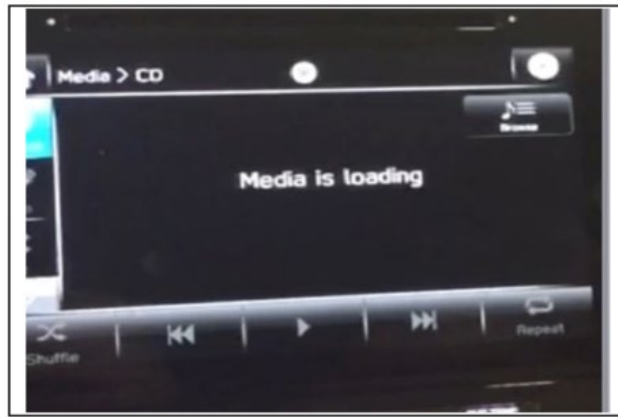
- 2- “Media is loading” is displayed on the screen but, the media never completes loading.

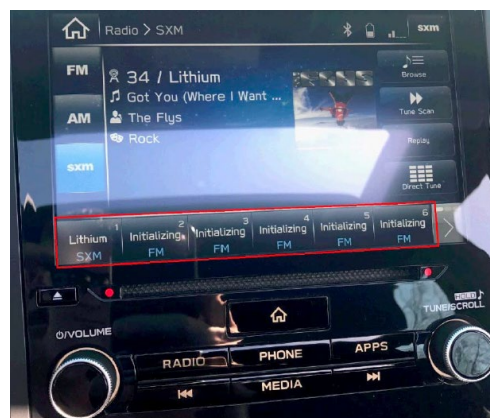
- 1- Radio station presets disappear (touch screen buttons return to “Initializing”).

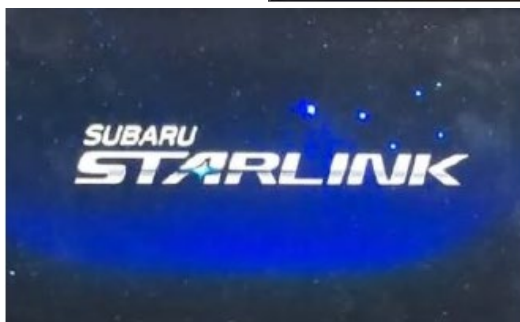
For reference, the previously released WTN-74R symptoms are also provided below. The main purpose of WTN-74R was to address display screen freeze-up during Back-Up Camera display (when the shifter is in “R”). In addition, the screen may also freeze when either the Subaru STARLINK or Disclaimer Caution / I Agree screen is displayed.

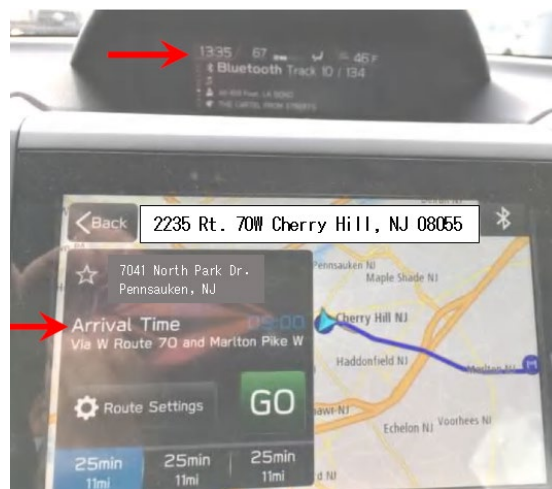
- 2) Time of day displayed in the MFD (Multi-Function Display) is incorrect and the arrival time displayed in Navigation units is also incorrect.

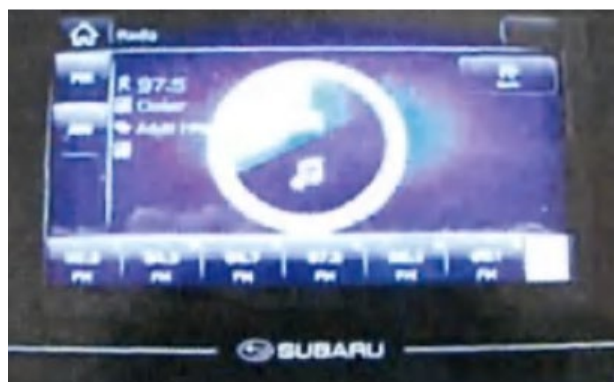
- 3) The time in the MFD automatically reverts to a "default" setting, even after setting the time using "Manual" mode.
- 4) Audio volume goes to maximum automatically after one click of the volume up button on the steering wheel. In some cases, this condition may also occur without input from the operator. Maximum volume is also displayed on the screen.
