**FIELD SERVICE CAMPAIGN – 18105**

20 June 2018

Vandal Lock Deviation Rework

IC Bus® CE Series

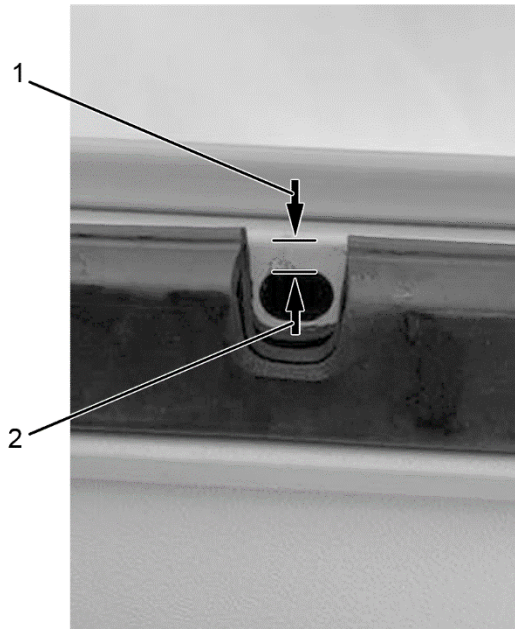
**Figure 1. Measurement**

1. Edge of casing
  2. Lock rod slot
7. Measure distance from edge of lock rod slot (Figure 1, Item 2) to edge of casing (Figure 1, Item 1).
- a. If measurement distance is greater than 7.8 mm (.307 in), proceed to Step 8.
  - b. If measurement distance is 7.8 mm (.307 in) or less, proceed to Step 21.

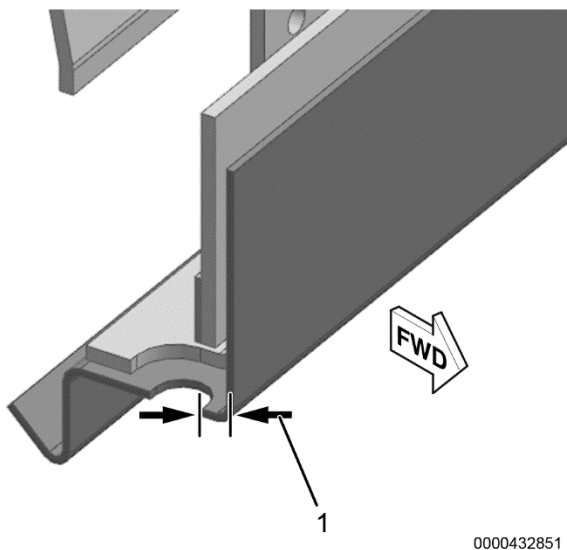
**Figure 2. Slot Measurement**

1. Lock rod slot
2. Edge of casing

8. Measure 7.8 mm (.307 in) from edge of casing (Figure 2, Item 2) toward lock rod slot (Figure 2, Item 1) and make a mark.
9. Using a step drill bit, enlarge slot to measured mark.

10. Using grit paper or mechanical file, ensure edges of slot are clear of any burrs or sharp edges.
11. Using a force gauge, check door locking resistance; force required to close door should be less than 30 lb.
  - a. If force is greater than 30 lb, proceed to Step 12.
  - b. If force is less than 30 lb, proceed to Step 15.
