| <b>Countries:</b> | CANADA, UNITED STATES | <b>Document ID:</b> | IK0900128 |

**Title:** Evaporator freeze up

**Applies To:** All Horizon Family (LT,RH, MV/HV) built before 5/25/18

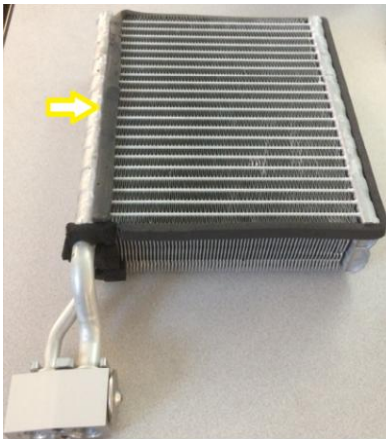
1. Inspection: Incorrect seal location

1. Remove evaporator, following steps in Master Service Information and relocate evaporator seal as shown.

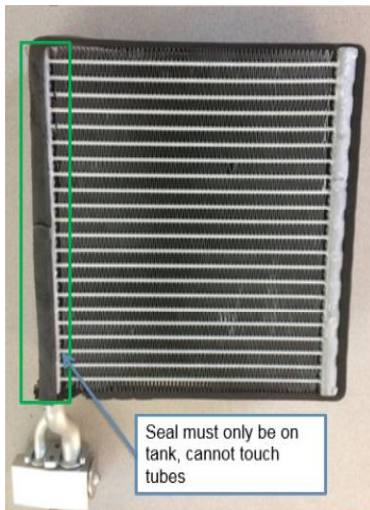
1. Correct seal location
