**Countries:** AUSTRALIA, CANADA, UNITED STATES **Document ID:** IK1201260  
**Availability:** ISIS, IsSIR **Revision:** 14  
**Major System:** ENGINES **Created:** 1/21/2015  
**Current Language:** English **Last Modified:** 6/22/2018  
**Other Languages:** [Français](#), [Español](#) **Author:** Allan Hertko  
**Viewed:** 5002

**Title:** 2015+ N13 Cylinder Pack - Update for Excessive Lubrication Oil Consumption

**Applies To:** 2015+ N13 ESN: 4400000-4401769

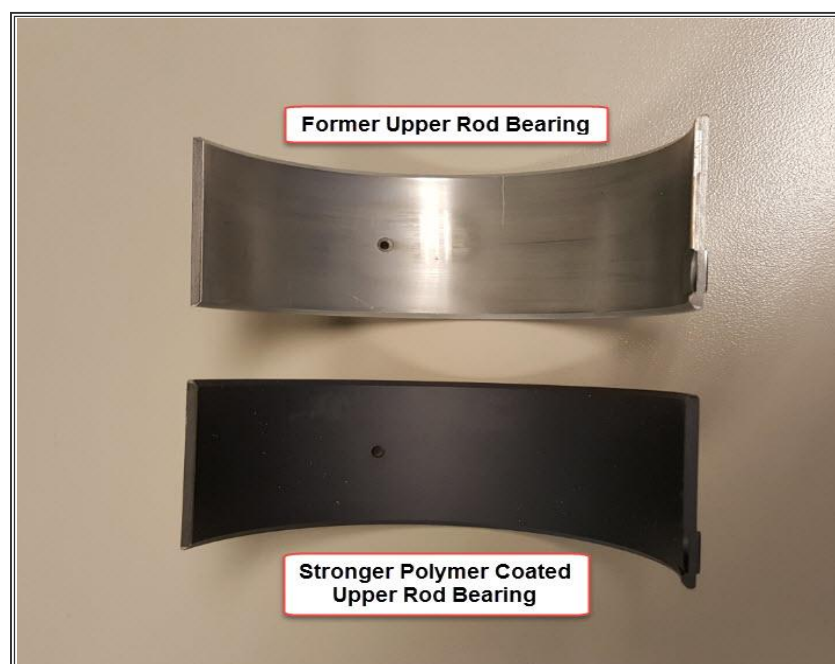
## Upper Rod Bearing Comparison

The 2513433C91 rod bearing set contains a stronger polymer coated upper bearing which is darker in color. This bearing replaces the former 3004714C91 and has been in service since 2015. The coating was added due to increased cylinder pressures found in the 2015 N13. There are no dimensional changes in the bearing, and it is backward compatible to all MaxxForce and N13 engines.
