Countries: CANADA, UNITED STATES **Document ID:** IK2600236
Availability: ISIS, FleetSIS, IsSIR **Revision:** 2
Major System: PROGRAMMING SUPPORT **Created:** 5/9/2018
Current Language: English **Last Modified:** 6/12/2018
Other Languages: NONE **Author:** Charles Schroeder
Viewed: 371

Title: Cummins ECM Programming Procedure for LT, HV, MV

Applies To: Cummins equipped LT, HV, MV

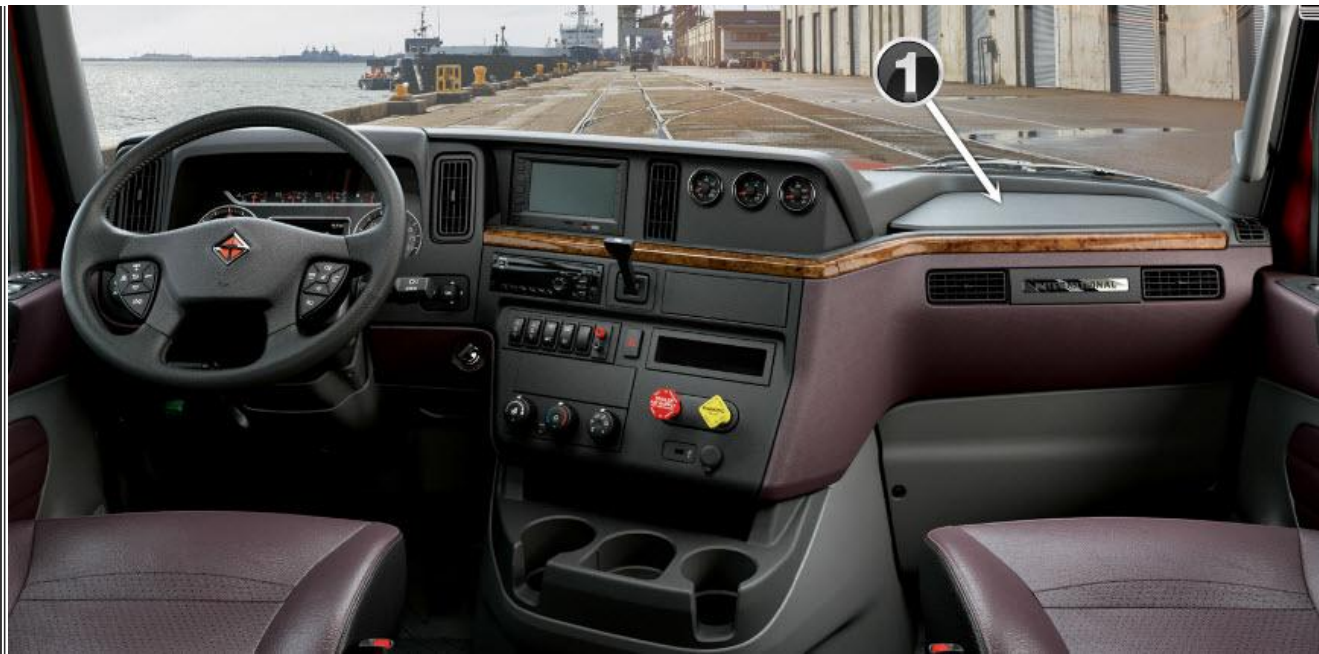
Figure 1 - Fuse Panel Location

1. Fuse Panel Cover

1. Remove the fuse panel cover located at the top of the dash on the passenger side of the vehicle.
2. Reference the fuse panel graphic and locate the fuse locations for **Driver Side Window/Door/Mirror** and **Passenger Side Window/Door**
3. Remove both fuses
4. Connect the the ECM using the vehicle 9-pin diagnostic connector
5. Update the ECM calibration with INSITE
6. Once all programming is complete disconnect the service tool from the vehicle 9-pin diagnostic connector
7. Re-install fuses for Driver Side Window/Door/Mirror and Passenger Side Window/Door
