# ***SERVICE PROCEDURE***

**18504**  
**June, 2018**

**SUBJECT:**    **SAFETY RECALL**  
**Brake Air Line Routing on certain International®**  
**HX® Series trucks built 08 December 2015 thru 10**  
**February 2018 with feature code 04091 (dual air**  
**brake system) and 04AZY (Antilock Brake System**  
**[ABS] with 6 channel Electronic Stability**  
**Protection [ESP])**

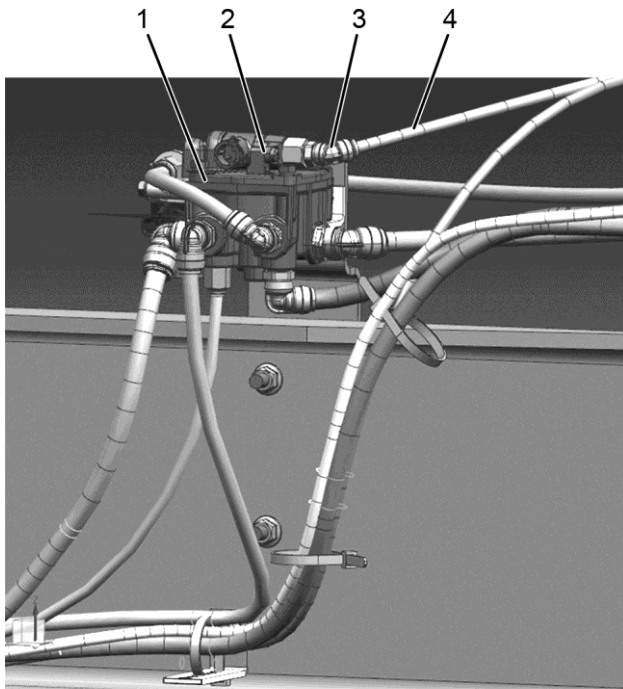
**Figure 1. ATR-6 Valve**

1. ATR-6 valve
  2. Control port
  3. 45-degree fitting
  4. 3/8-inch ORANGE airline
- 
6. Disconnect ORANGE 3/8-inch airline (Figure 1, Item 4) from 45-degree fitting (Figure 1, Item 3) of ATR-6 control port (Figure 1, Item 2).
  7. Remove and discard 45-degree fitting (Figure 1, Item 3) from ATR-6 control port (Figure 1, Item 2).

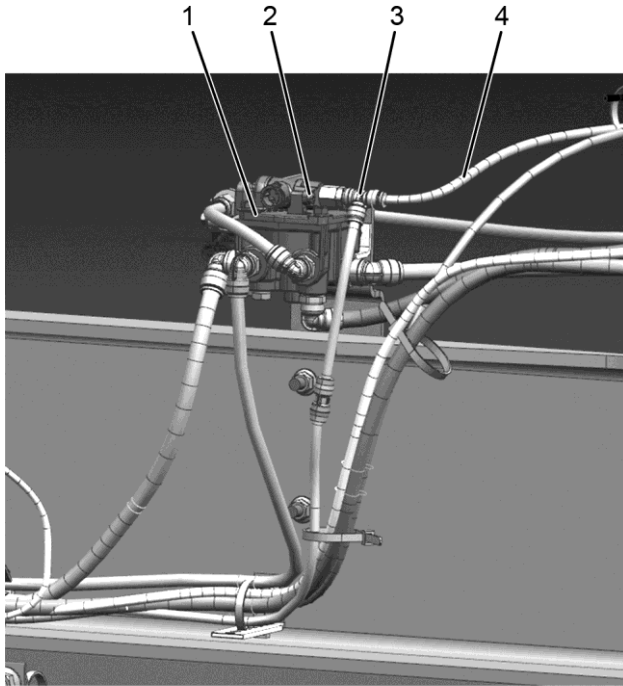
**Figure 2. Tee-Fitting**

1. ATR-6 valve
2. Control port
3. 3/8-inch T-fitting
4. 3/8-inch ORANGE airline

8. Install new 3/8-inch T-fitting (Figure 2, Item 3) into ATR-6 control port (Figure 2, Item 2) and hand tighten nut.
9. Tighten fitting 1-1/2 to 2 full revolutions.
10. Install ORANGE 3/8-inch airline (Figure 2, Item 4) into 3/8-inch T-fitting (Figure 2, Item 3).

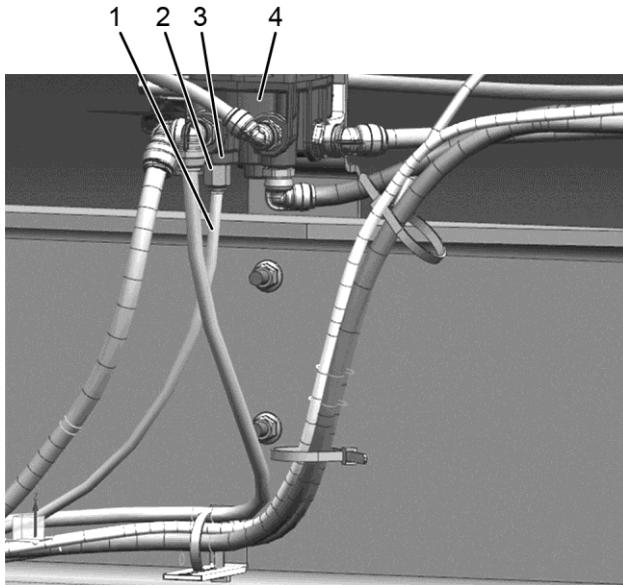
**Figure 3. ATR-6 Steer Axle Delivery**

1. 3/8-inch ORANGE airline
  2. 3/8-inch fitting
  3. Steer axle delivery port
  4. ATR-6 valve
- 
11. Disconnect ORANGE 3/8-inch airline (Figure 3, Item 1) from 3/8-inch fitting (Figure 3, Item 2) of ATR-6 steer axle delivery port (Figure 3, Item 3).
  12. Remove and discard 3/8-inch fitting (Figure 3, Item 2) from ATR-6 steer axle delivery port (Figure 3, Item 3).

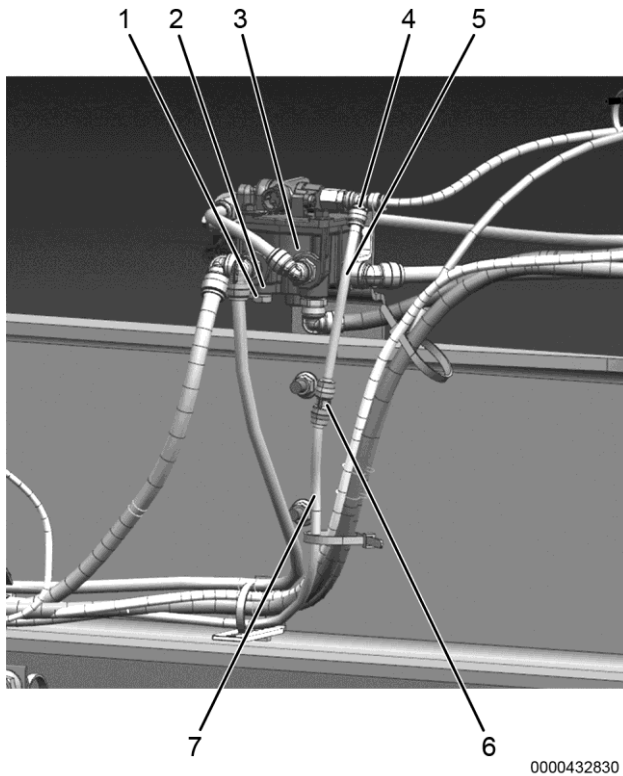
**Figure 4. ATR-6 Connections**

1. 3/8-inch plug
2. ATR-6 steer axle delivery port
3. ATR-6 valve
4. 3/8-inch T-fitting
5. 7-inch (180 mm) length 3/8-inch ORANGE airline
6. 3/8-inch coupler
7. Lower 3/8-inch ORANGE airline

13. Install 3/8-inch plug (Figure 4, Item 1) into ATR-6 steer axle delivery port (Figure 4, Item 2) and tighten until plug is hand tight.
14. Tighten plug 1 1/2 to 2 full revolutions.
15. Install one end of 7-inch (180 mm) length 3/8-inch ORANGE airline (Figure 4, Item 5) into 3/8-inch coupler (Figure 4, Item 6).
16. Install 3/8-inch coupler (Figure 4, Item 6) onto lower 3/8-inch ORANGE airline (Figure 4, Item 7).

17. Install remaining end of 7-inch (180 mm) length 3/8-inch ORANGE airline (Figure 4, Item 5) into 3/8-inch T-fitting (Figure 4, Item 4).
18. Verify no air leaks are present when pedal is depressed.
19. Remove wheel chocks.
