MIL "ON" DTC P3190 - (Poor Engine Power) at High Altitude With High Temperatures

YEAR(S)	MODEL(S)	ADDITIONAL INFORMATION
2017 - 2018	Highlander HV	VDS(s): BGRFH, DGRFH, JGRFH

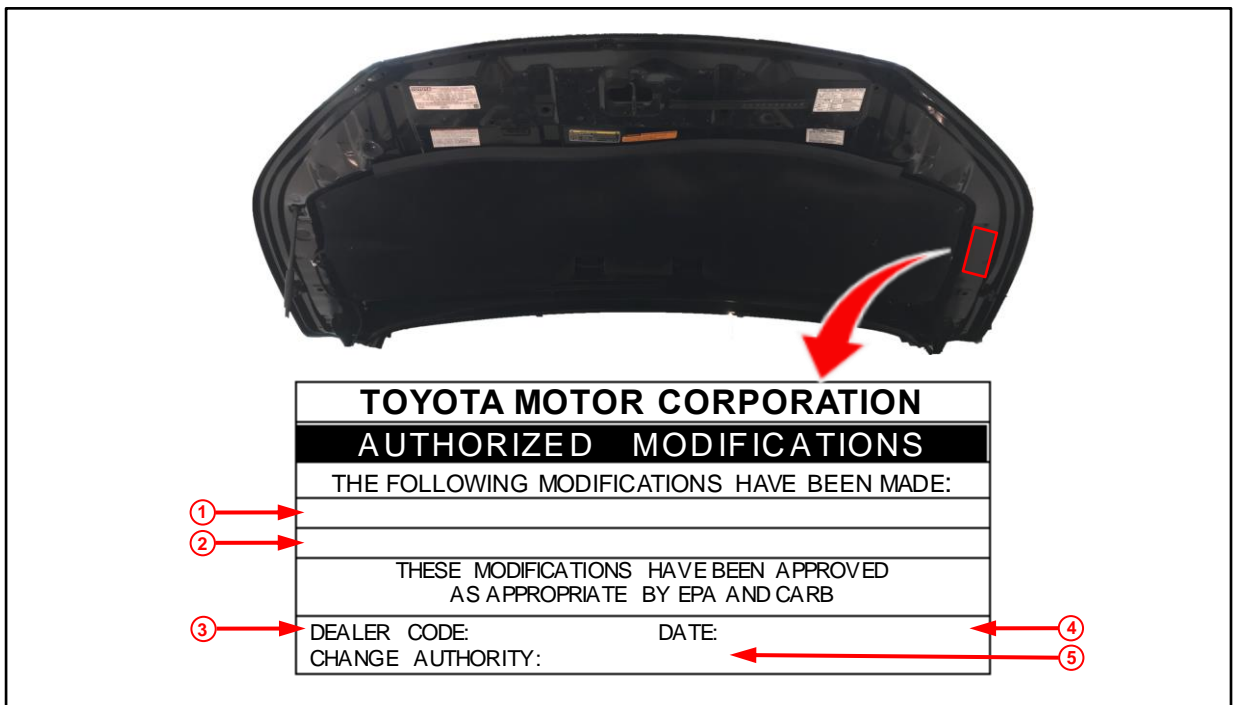
Figure 1. Location of Authorized Modifications Label for 2017 – 2018 Highlander HV

5. Check for the Authorized Modifications Label affixed to the vehicle in the location shown below. Confirm if the ECM (PCM) calibration has been updated.

7. Prepare and install the Authorized Modifications Label.
 - A. Using a permanent marker, enter the following information on the label:
 - ECM (PCM) part number [*Refer to the **Parts Information** section for the **NEW PART NUMBER***]
 - Calibration ID(s) [*Refer to the **Calibration Information** section for the **NEW CALIBRATION ID***]
 - Dealer Code
 - Repair Date
 - Change Authority [***This bulletin number***]
 - B. Affix the Authorized Modifications Label to the vehicle at the location shown in Figure 1. The Authorized Modifications Label is available through the MDC, P/N 00451-00001-LBL.
8. Perform a Health Check to confirm that the NEW calibration updated successfully.
9. Ready the vehicle ON, warm it up to normal operating temperature, and test drive to confirm proper vehicle operation.
