# Vehicle Surge Between 40 and 50 mph

**Service Category** Drivetrain

**Section** Automatic Transmission/Transaxle

## Applicability

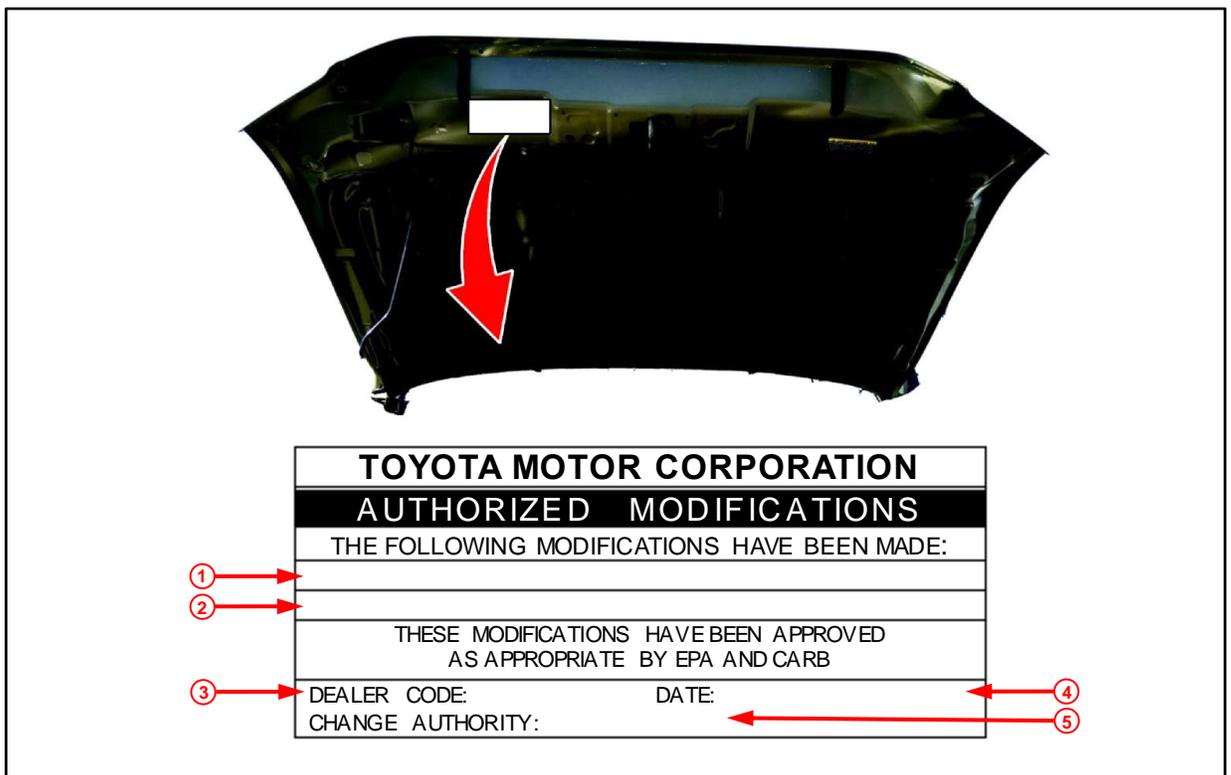
**Figure 1. Location of Authorized Modifications Label for 2016 – 2017 Tacoma**

<b>1</b>	<b>Replacement ECM (PCM) Part Number (e.g., 89661-04K54)</b>
<b>2</b>	<b>New Calibration ID (e.g., 8966304B0400)</b>
<b>3</b>	<b>Dealer Code</b>

<b>4</b>	<b>Date Completed</b>
<b>5</b>	<b>This SB Number</b>

2. Check for the Authorized Modifications Label affixed to the vehicle in the location shown below. Confirm if the ECM (PCM) calibration has been updated.  
Is the calibration ID listed the latest ECM (PCM) calibration?
  - **YES** — This bulletin does NOT apply. Continue diagnosis using the applicable Repair Manual.
  - **NO** — Continue to step 3.

B. Install the Authorized Modifications Label on the vehicle at the location shown in Figure 1. The Authorized Modifications Label is available through the MDC, P/N 00451-00001-LBL.
