"Low Engine Oil" Message

Service Category Engine/Hybrid System

Section Lubrication

YEAR(S)	MODEL(S)	ADDITIONAL INFORMATION
2018	LS500, LS500H	VDS(s): B51FF, B5LFF, BYLFF, C51FF, C5LFF, CYLFF

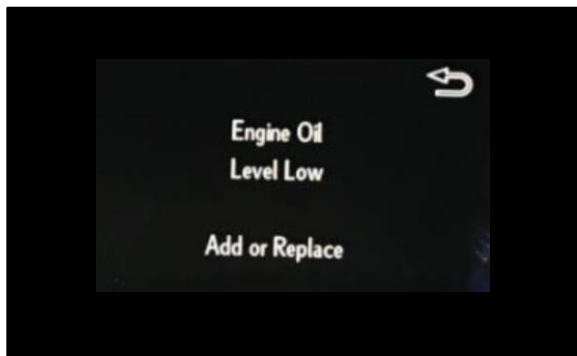
Some 2018 model year LS500 and LS500h vehicles may exhibit a warning message either under the speedometer ("Engine Oil Level Low Add or Replace") or on the Navigation screen ("Low Engine Oil"). Follow the Repair Procedure in this bulletin to address this condition.

Figure 1. Warning Message Under the Speedometer

4. Flash reprogram the combination meter ECU.

Follow the procedures outlined in Service Bulletin No. [L-SB-0001-18](#) "Techstream ECU Flash Reprogramming Procedure," and flash the combination meter ECU with the NEW calibration file update.

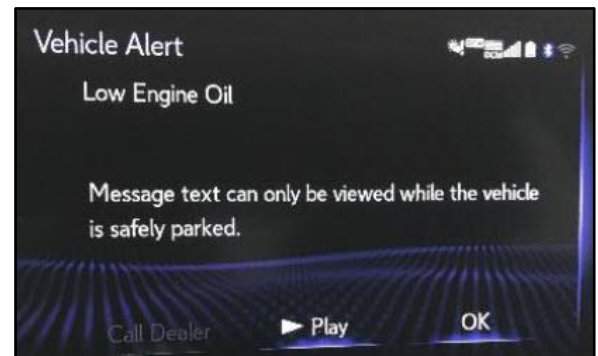
Figure 2. Warning Message on the Navigation Screen
