2GR-FKS Engine Oil Leak From Cam Sensor Bolt Hole(s)

Service Category Engine/Hybrid System

YEAR(S)	MODEL(S)	ADDITIONAL INFORMATION
2016 - 2018	RX350	VDS(s): BZMCA, ZZMCA

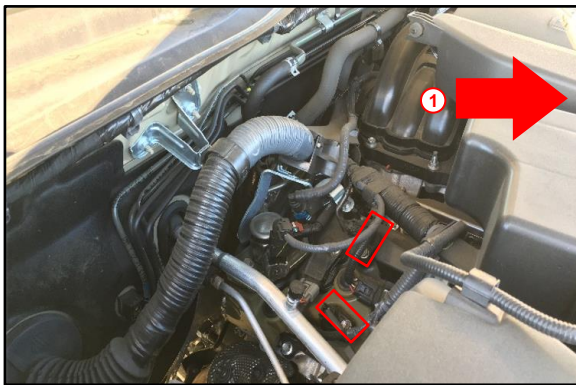
Figure 1. Cam Sensor Locations

Some 2016 – 2018 model year RX350 vehicles equipped with a 2GR-FKS engine may exhibit an oil leak from the cam sensor bolt hole(s). Follow the Repair Procedure in this bulletin to address this condition.

Does the vehicle exhibit an oil leak from one or more cam sensor bolt holes?
(Refer to Figures 1 – 4.)

2. Remove the affected cam housing.

3. Install the NEW cam housing.

Replace ALL cam sensor bolts on the NEW cam housing with the supplied bolts. Do NOT reuse the old cam sensor bolts.

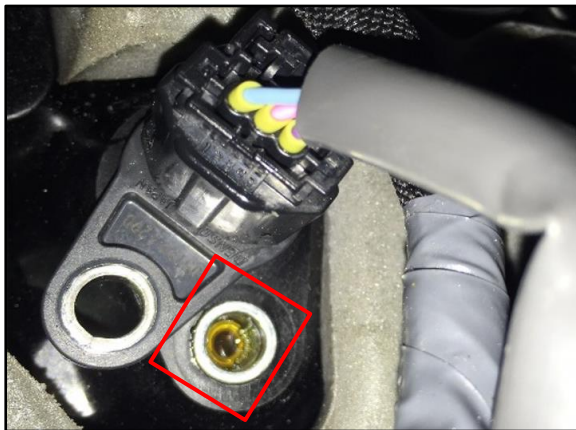
Figure 3. Engine Oil in Cam Sensor Bolt Hole

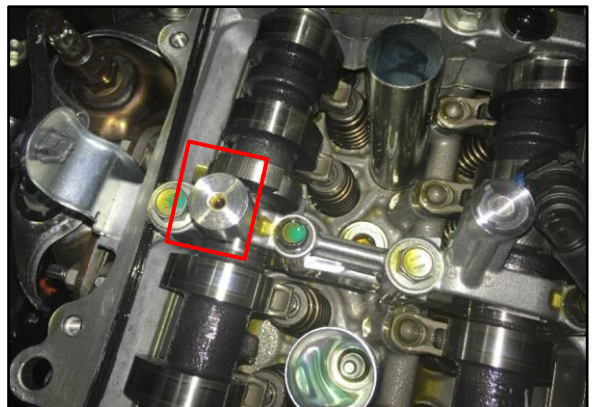
Figure 4. Cam Sensor Bolt Hole (Valve Cover Removed)
