Random Misfire Under High Load

Service Category Engine/Hybrid System

Section Engine Control

Introduction

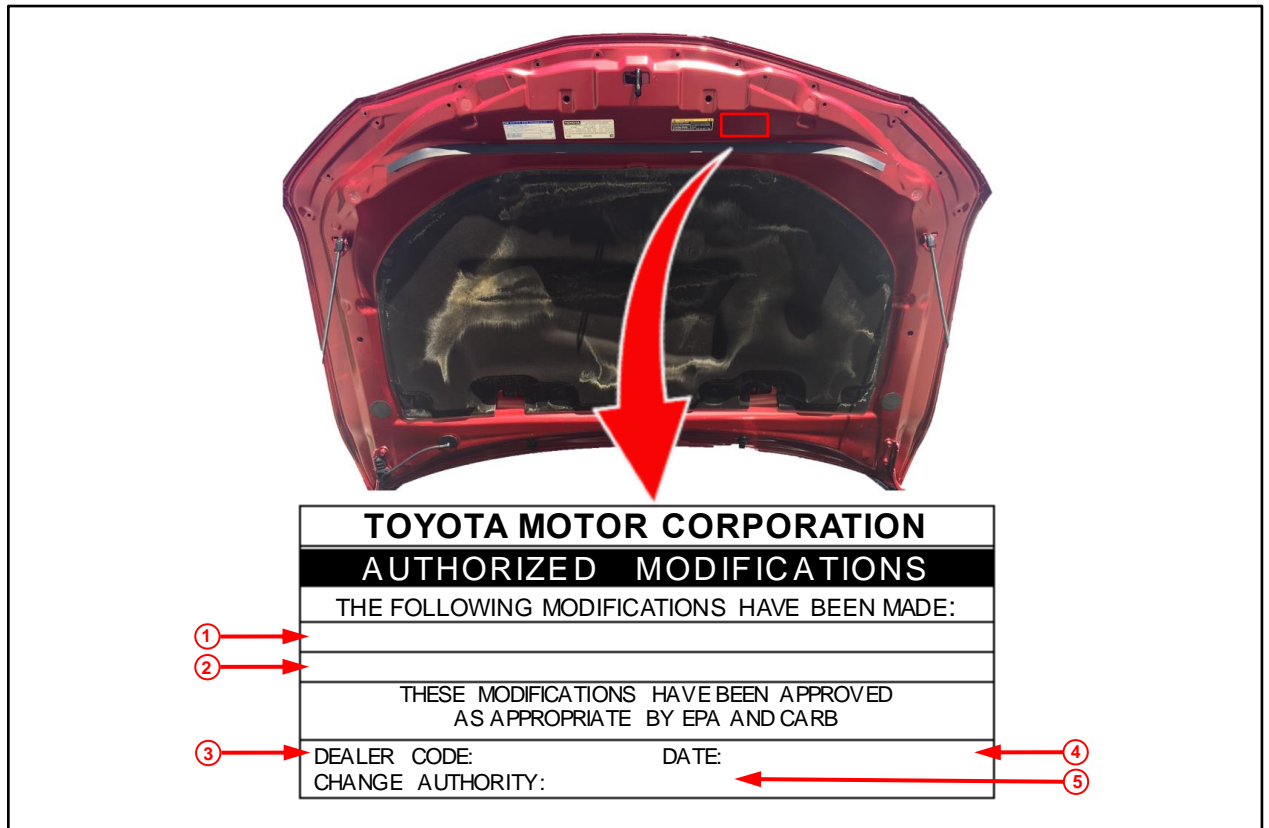
Figure 1. Location of Authorized Modifications Label on 2018 Camry

- Check for the Authorized Modifications Label affixed to the vehicle in the locations shown below. Confirm if the ECM (PCM) calibration has been updated.

B. Install the Authorized Modifications Label onto the vehicle at the location shown in Figure 1. The Authorized Modifications Label is available through the MDC, P/N 00451-00001-LBL.
